Lymington Ferries Summer Review 2009

Reference: 31098//D0356/Issue 1.1

Date: 19 November 2009

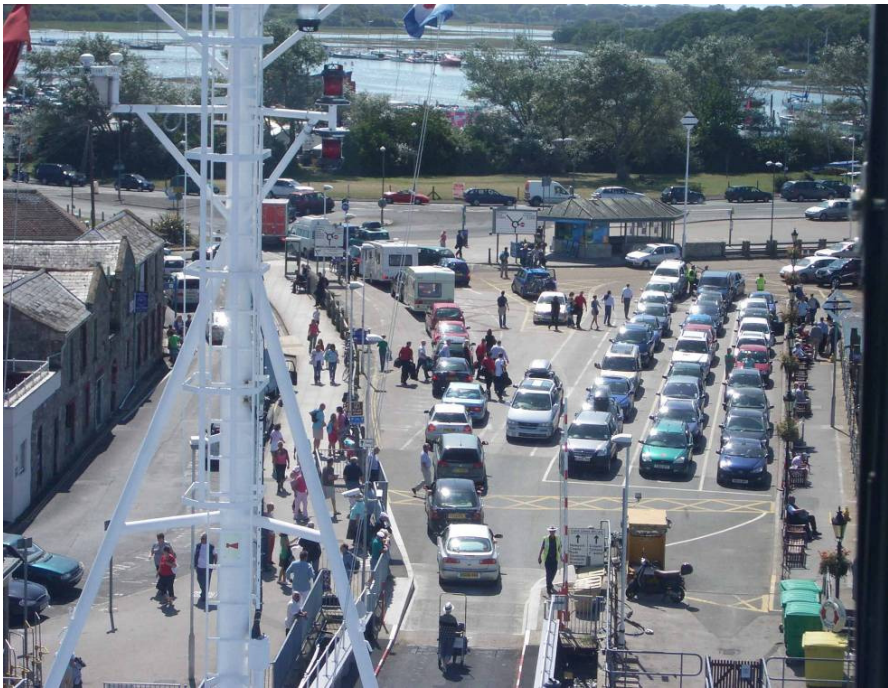
Figure 1: Departing Traffic Congestion at Yarmouth.

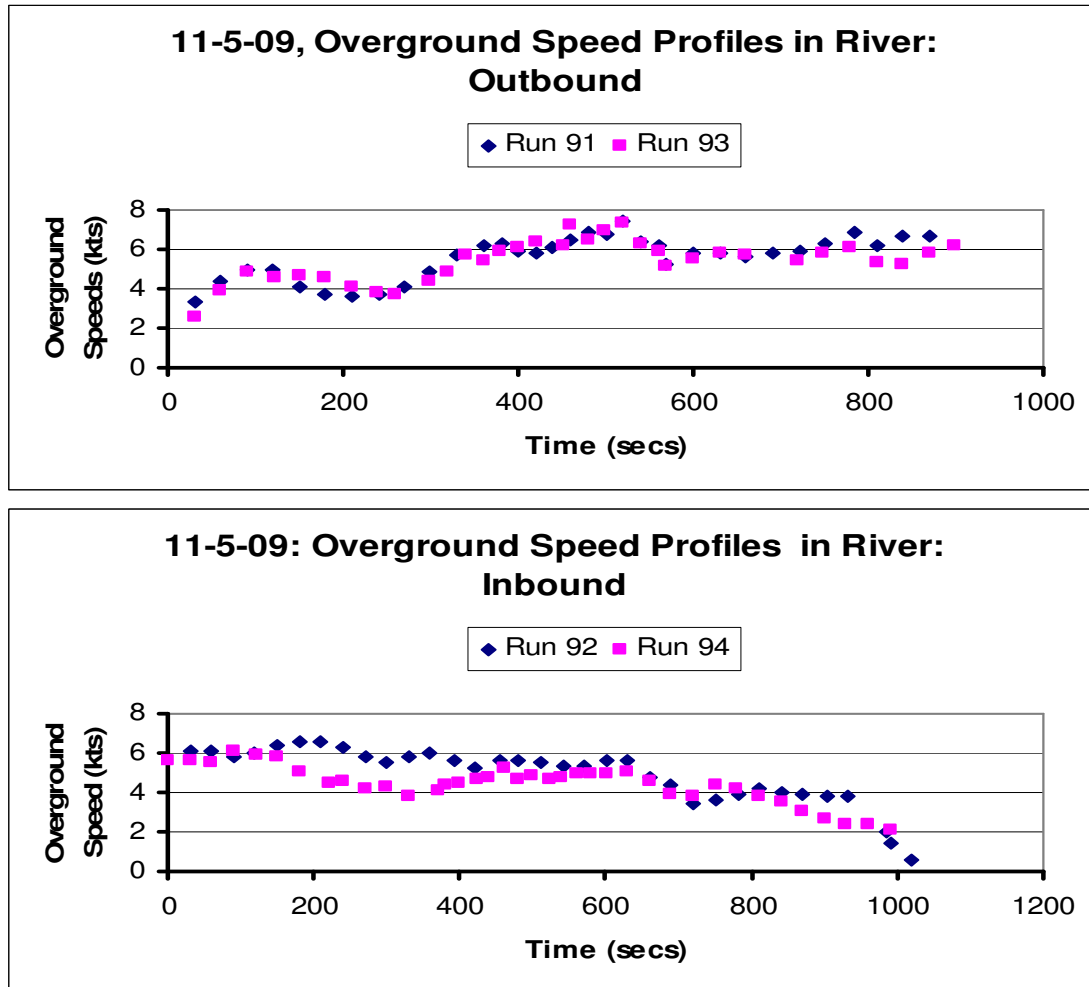
It is seen that ground speeds in excess of 6 knots were measured around 400 seconds into the run, just after rounding Cocked Hat bend. This was within the tolerance level on overground speed which allows for increases due, among other things, to following currents. Both runs 91 and 93 were subject to following mid-ebb currents in Short Reach and a strong following wind on rounding Cocked Hat bend; inbound runs 92 and 94 were subject to heading currents and a strong head wind and their overground speed did not exceed 6 knots at the same location.

Figure 8: Measured Overground Speeds on 11 May 2009: Wight Sky

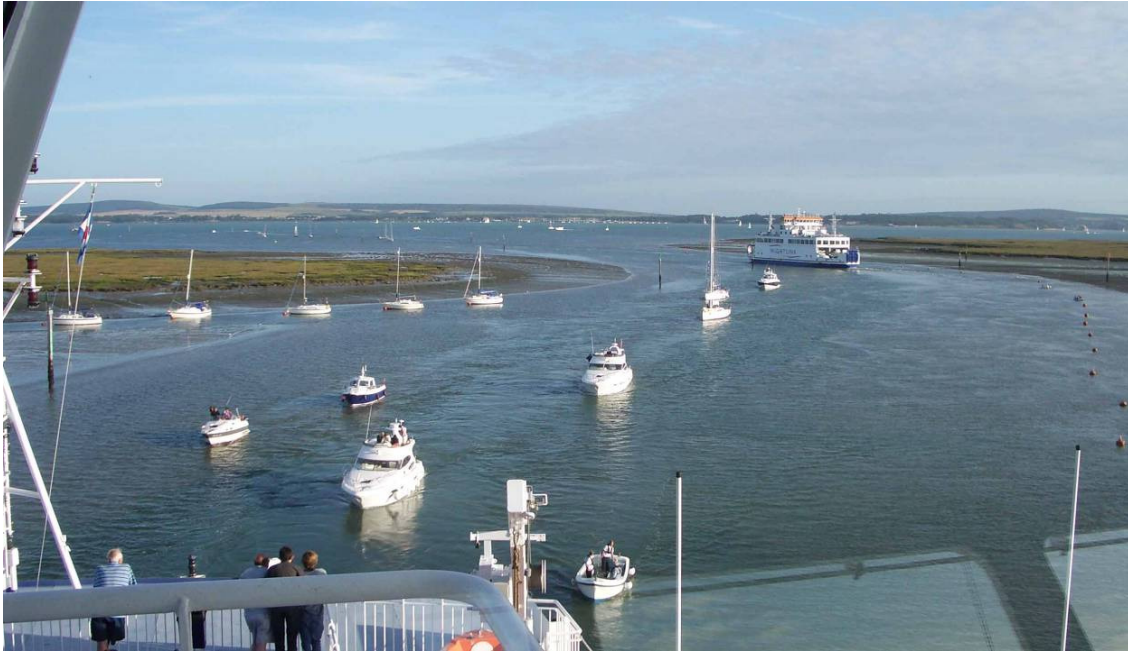
One inbound passage at very low water was witnessed on board the Wight Light. This occurred in the late afternoon when leisure traffic was returning to the river, most of which lined astern of the ferry and followed it in (see Figure 19).

Figure 19: Leisure Craft Following the inbound Ferry at LWS (18:26 BST) on 22 August

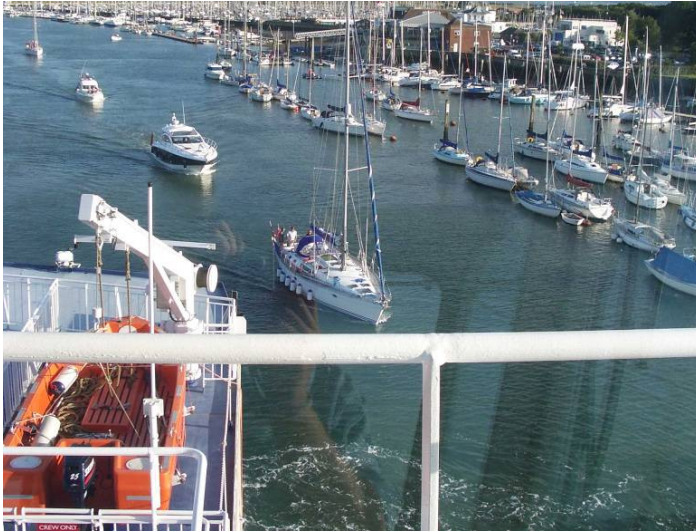
Figure 20: Leisure Craft passing Berthing Ferry at LWS (18:37 BST) on 22 August

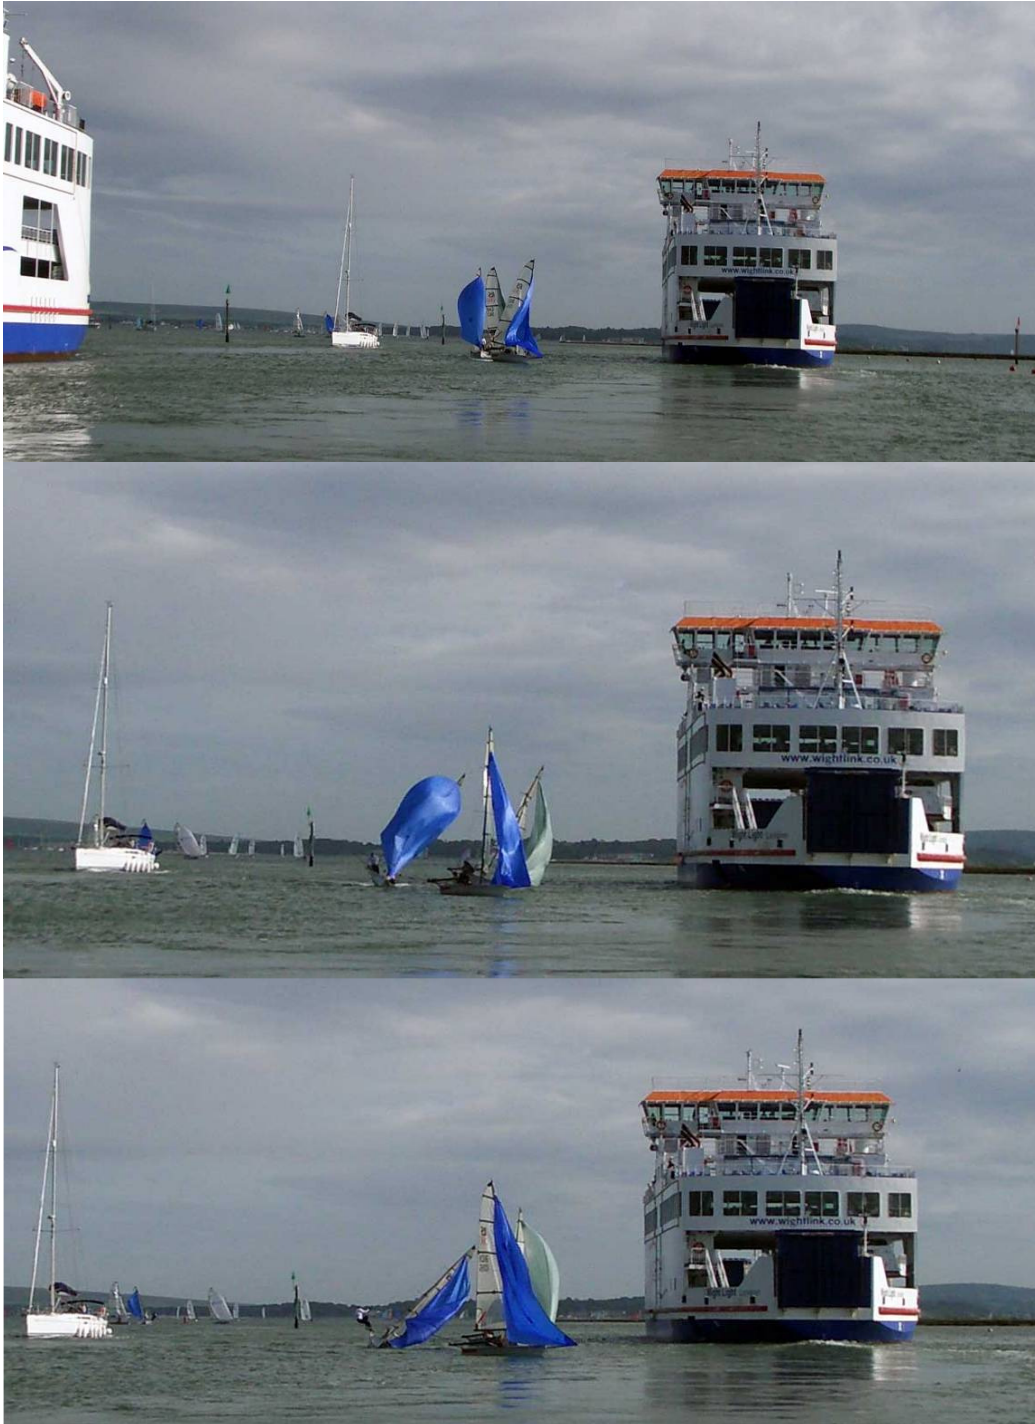
The progressive nature of the incident can be seen clearly from the sequence, as can the fact that, in the last of the sequence, the first boat of the three is in clearer wind and beginning to reach away. All three boats recovered well and none of them capsized.

Figure 23: Effect of Ferry Wind Shadow on three RS dinghies

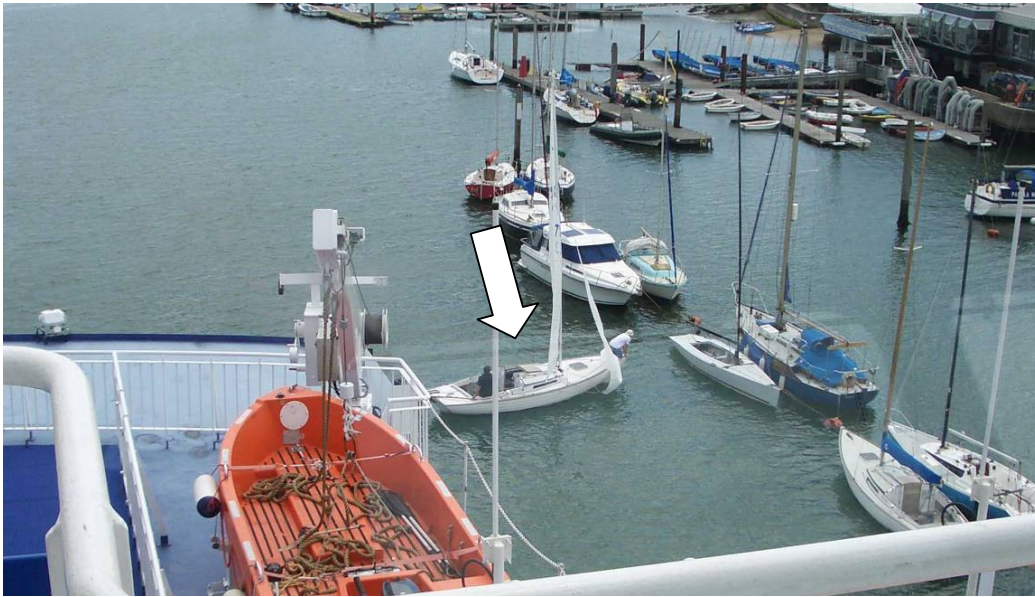
happen in the wind shadow (c.f. the RS dinghy incident) and, if possible, avoid sailing past a ferry while it is berthing at the Lymington linkspan (c.f. the Folkboat incident).

Figure 25: Folkboat in Wind Shadow

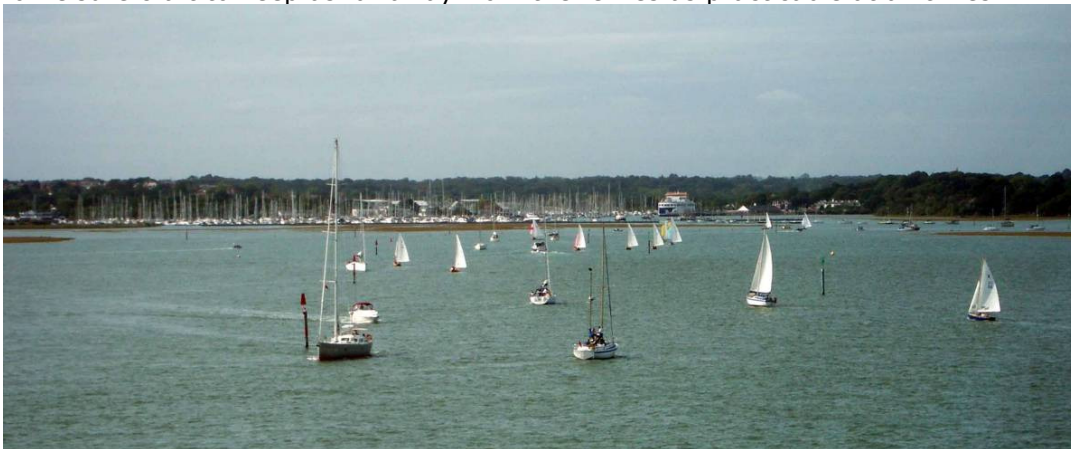
There were some instances of boats cutting across the path of the ferries in the river, but, although some could be classed as "impeding a ferry" (a vessel constrained by its draught) there were no significant safety issues. However, it remains a recommendation for leisure craft to keep as far away from the ferries as practicable at all times.

Figure 26: Poor Lane Discipline in Long Reach at 15:55 on 22 August

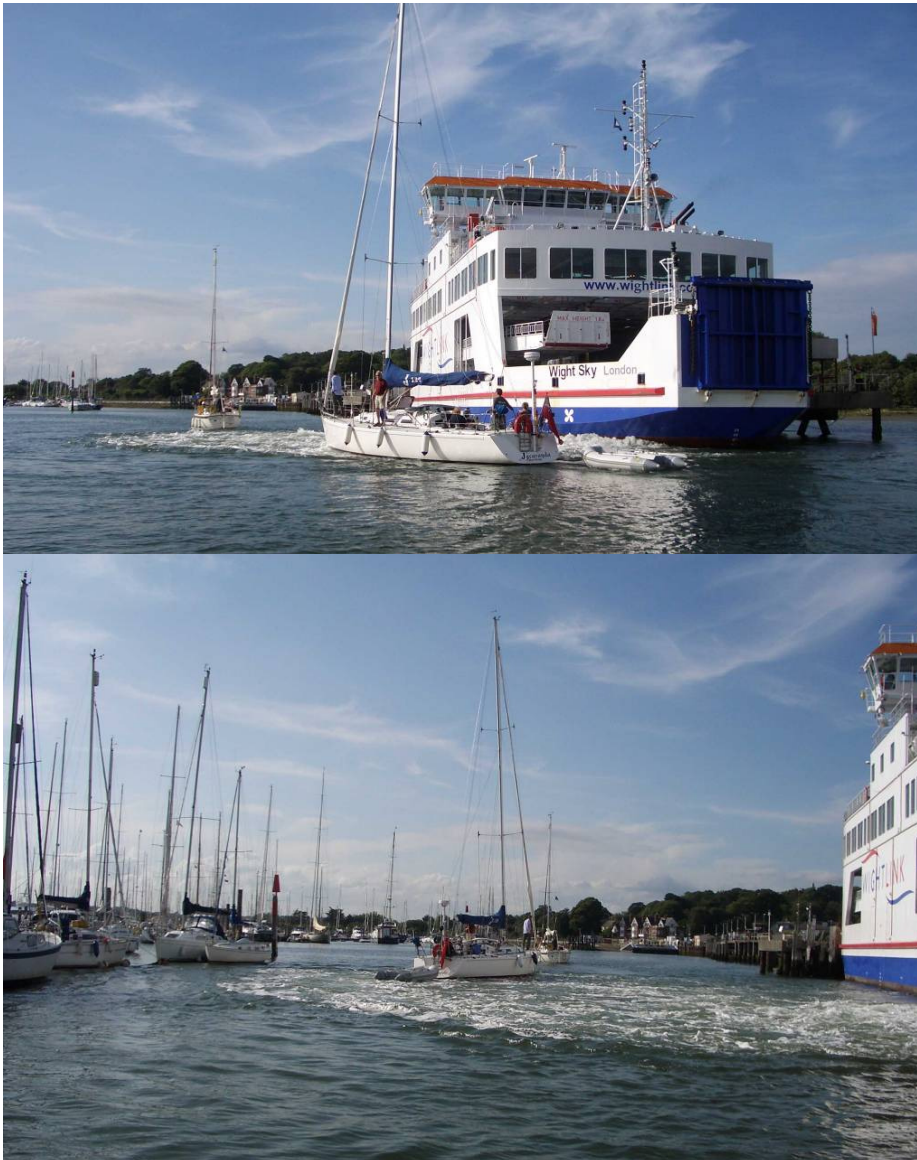
Berthing at Lymington causes thruster slipstreams to form in the path of passing leisure craft. It is understandable that leisure craft held up astern of an inbound ferry as it slows to approach the berth would wish to pass once it heads to the linkspan at Lymington. However, it should be noted that the following considerations apply:

Figure 28: Effect of Aft Thruster Slipstream during Ferry Berthing.

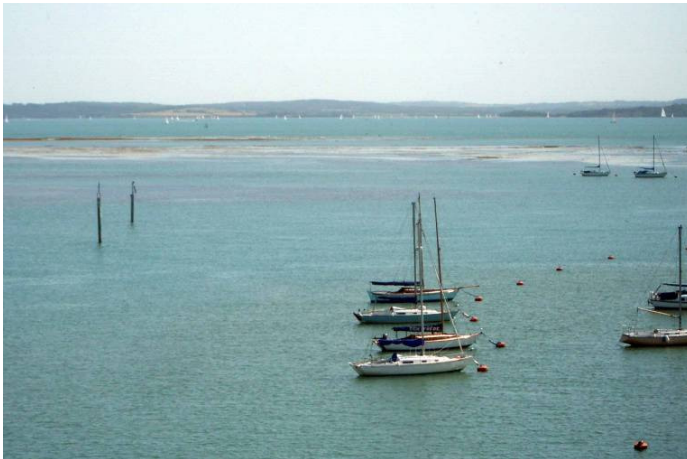
As discussed in Reference 1, boats on the moorings on the western side of Short Reach near the Cocked Hat post can, under certain conditions of wind and tide, intrude into the navigation channel; an example is shown in Figure 29, taken from a ferry rounding the Cocked Hat bend. In the event, there was little traffic around at the time and, in the high water conditions prevailing, there was little in the way of current; there was also adequate water space and depth. From a navigation perspective, however, it would be preferable if these moorings were not used, especially when the traffic density is high.

Figure 29: Boats Moored in Short Reach

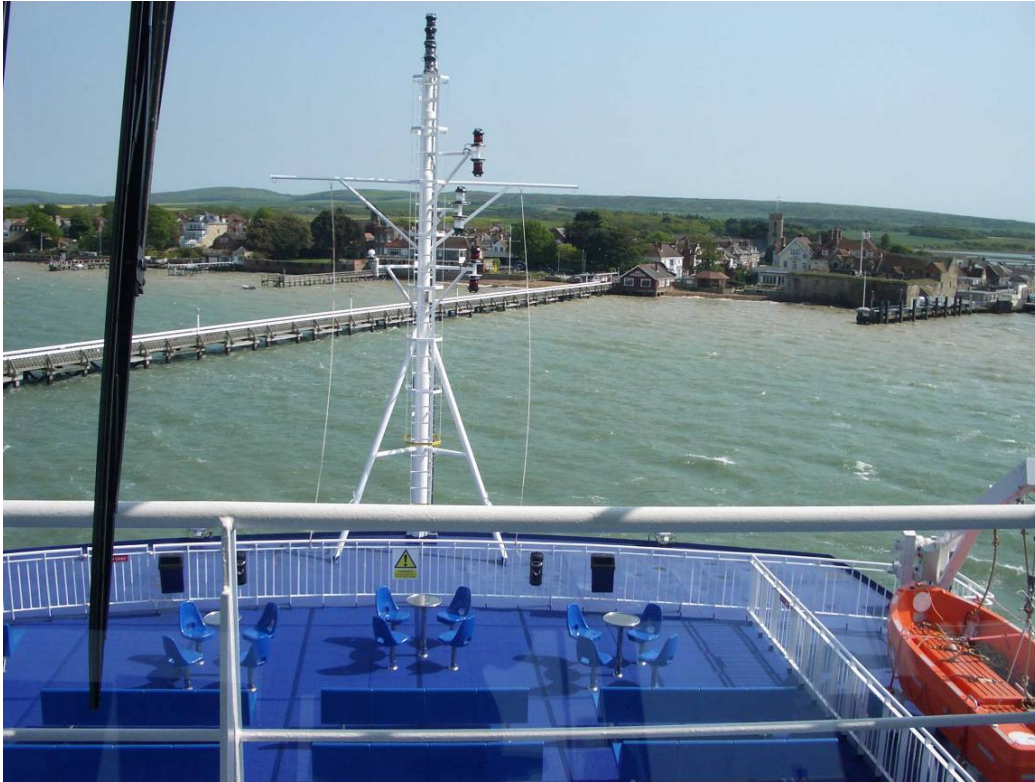
- The magnitude of the ebb was illustrated at Yarmouth where, as seen in Figure 1, a drift angle in excess of 30° was needed to ease toward the link span while maintaining a course-made-good parallel to the "long pier";
- While the river and Solent passage had been coned from the centre of the bridge, berthing at Yarmouth was carried out from the port bridge wing. On the first trip this caused no problems and hand-over from the centre con to the wing was achieved satisfactorily;
- This was not the case on the next arrival at Yarmouth when the hand-over failed at about 1720 BST. This occurred at a location just before that depicted in Figure 1 for the previous arrival and it took some time before the Master recovered the situation at the centre con.

Figure 1: Arrival at Yarmouth at about 1530 BST on 11 May 2009

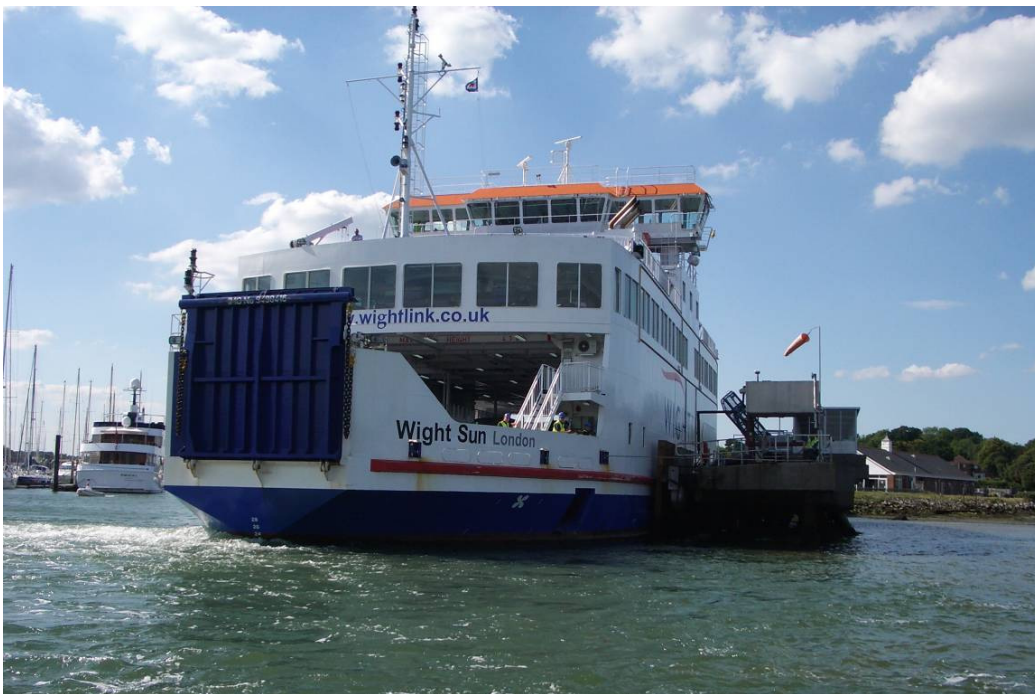
Final berthing was carried out from the starboard bridge wing after a trouble-free hand-over, and it was clear that fairly firm aft thruster action was needed to bring the stern in against the easterly wind. Once the mooring lines were ashore, the master stayed on the bridge to operate the aft thruster as necessary to keep the stern under control while the ship was in the Linkspan (see Figure 3).

Figure 3: Use of Stern Thruster while Alongside

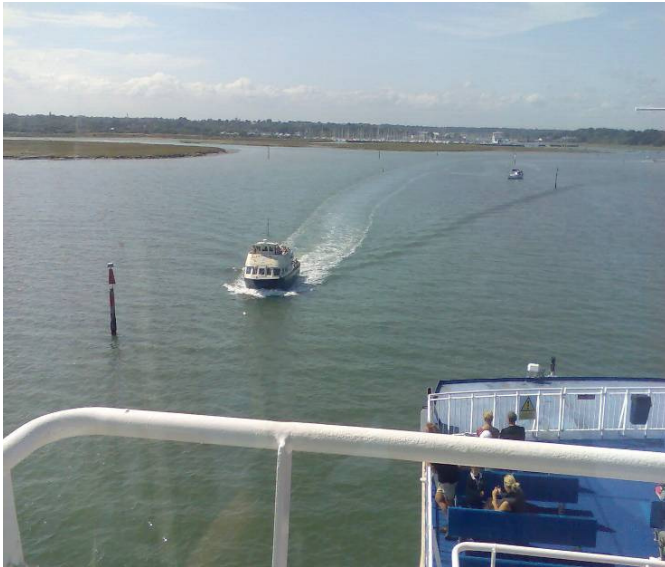
The Wight Sky left Yarmouth at about 1705 and entered the river at about 1735. The first observation was the heavy dinghy traffic returning to Lymington from racing. Generally this traffic kept out of the channel and caused the ferry no difficulty. At about 1737 we did observe heavy wash from the Nauti Bear (outbound at about No 6).

Figure 3: Wash created by the NAUTI BEAR observed from WIGHT SKY

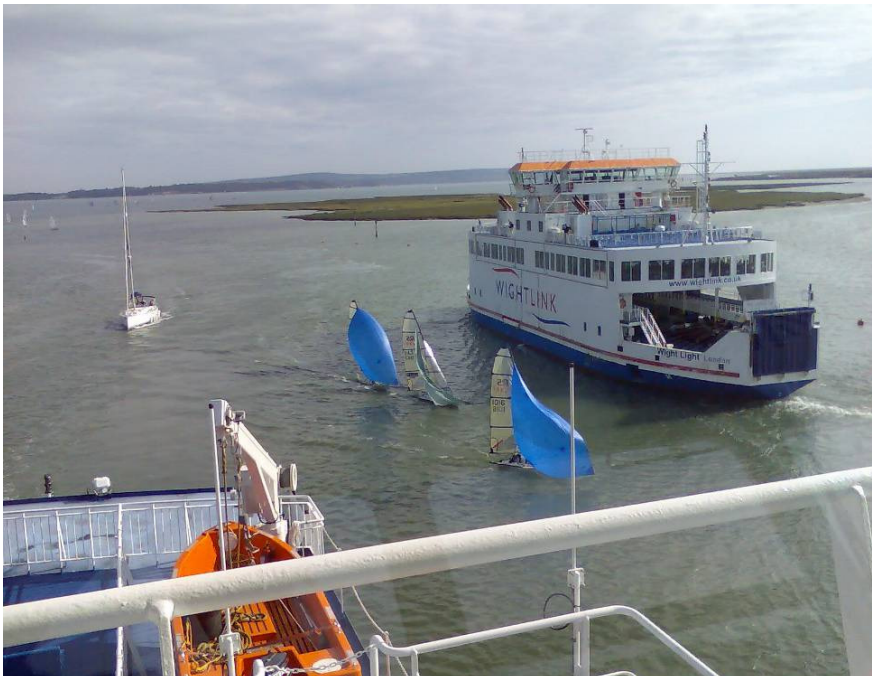
A potentially serious incident occurred as the Wight Sky and Wight Light were passing in the passing place at about 1740. Three RS craft, Nos 1016, 943 and 1114 were behaving as though racing in the channel, with full spinnakers flying. They opted to try and overtake the Wight Sky, passing between her and the outbound Wight Light in the middle of the channel. One nearly capsized and this behaviour did cause alarm on the Wight Sky bridge. (see photograph below.)

Figure 4: RS craft overtaking WIGHT SKY

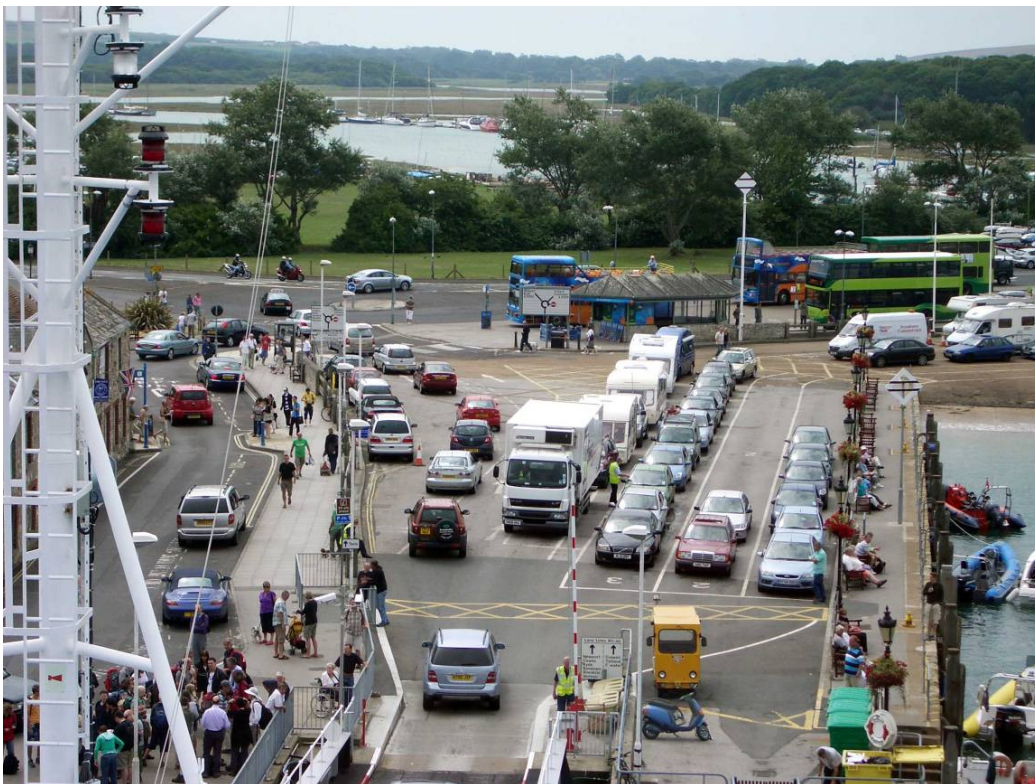
Once the Wight Light berthed at Yarmouth another source of delay manifested itself. The lanes on shore in which the next load for the Wight Light was mustered were full and road traffic in Yarmouth near the terminal was relatively heavy. As a result, the vehicles unloading from Wight Light were held up once they reached the roundabout outside the terminal, with the queue stretching back into the ferry, thereby delaying unloading which was finally completed some 8 minutes after arrival. Figure 2 shows the situation once things had eased, but the source of congestion and delay are apparent.

Figure 2: Unloading and Potential for Congestion at Roundabout

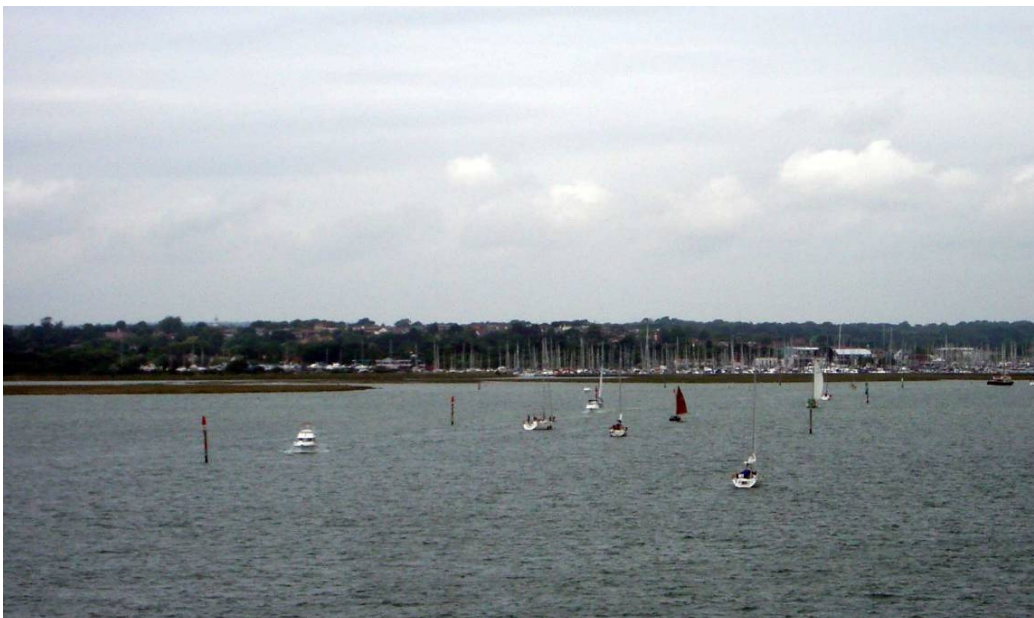
Figure 4: Traffic Discipline in Long Reach with some vessels on wrong side of channel

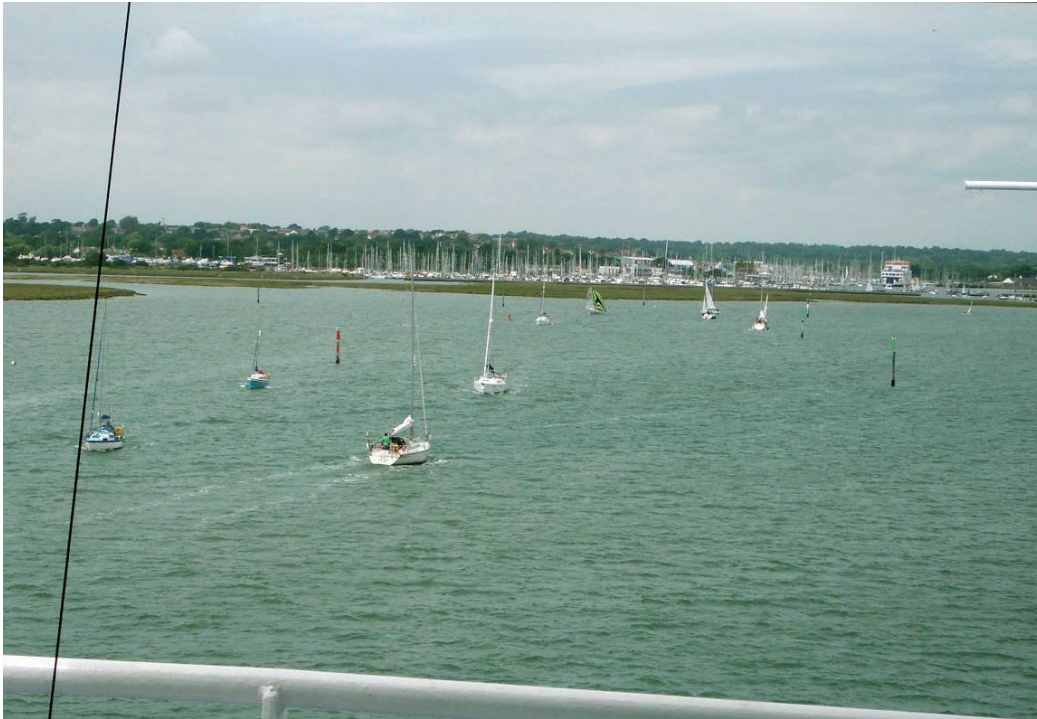
Figure 5: Traffic discipline in Long Reach with one vessel on wrong side of channel

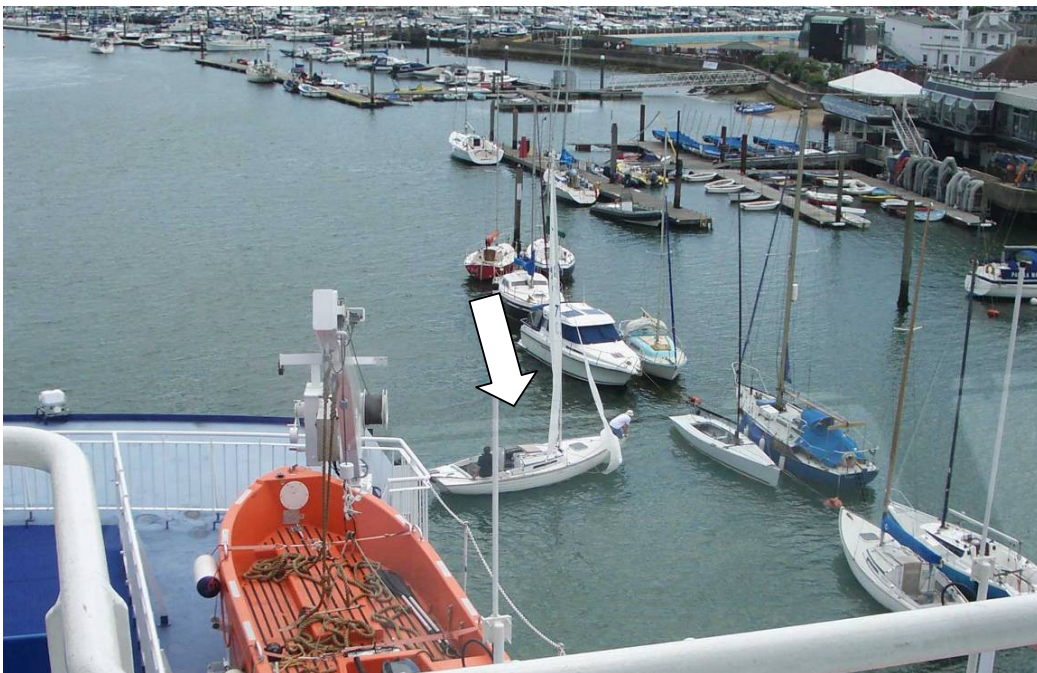
Wind shadow effects noted from the ferry were mostly those affecting the larger sailing vessels; they were generally minor, and over quickly. This was not the case with the dinghies as will be described in Section 2.2 below. However, an incident with a Folkboat is relevant and Figure 6 serves to illustrate this.

Figure 6: Folkboat in Wind Shadow

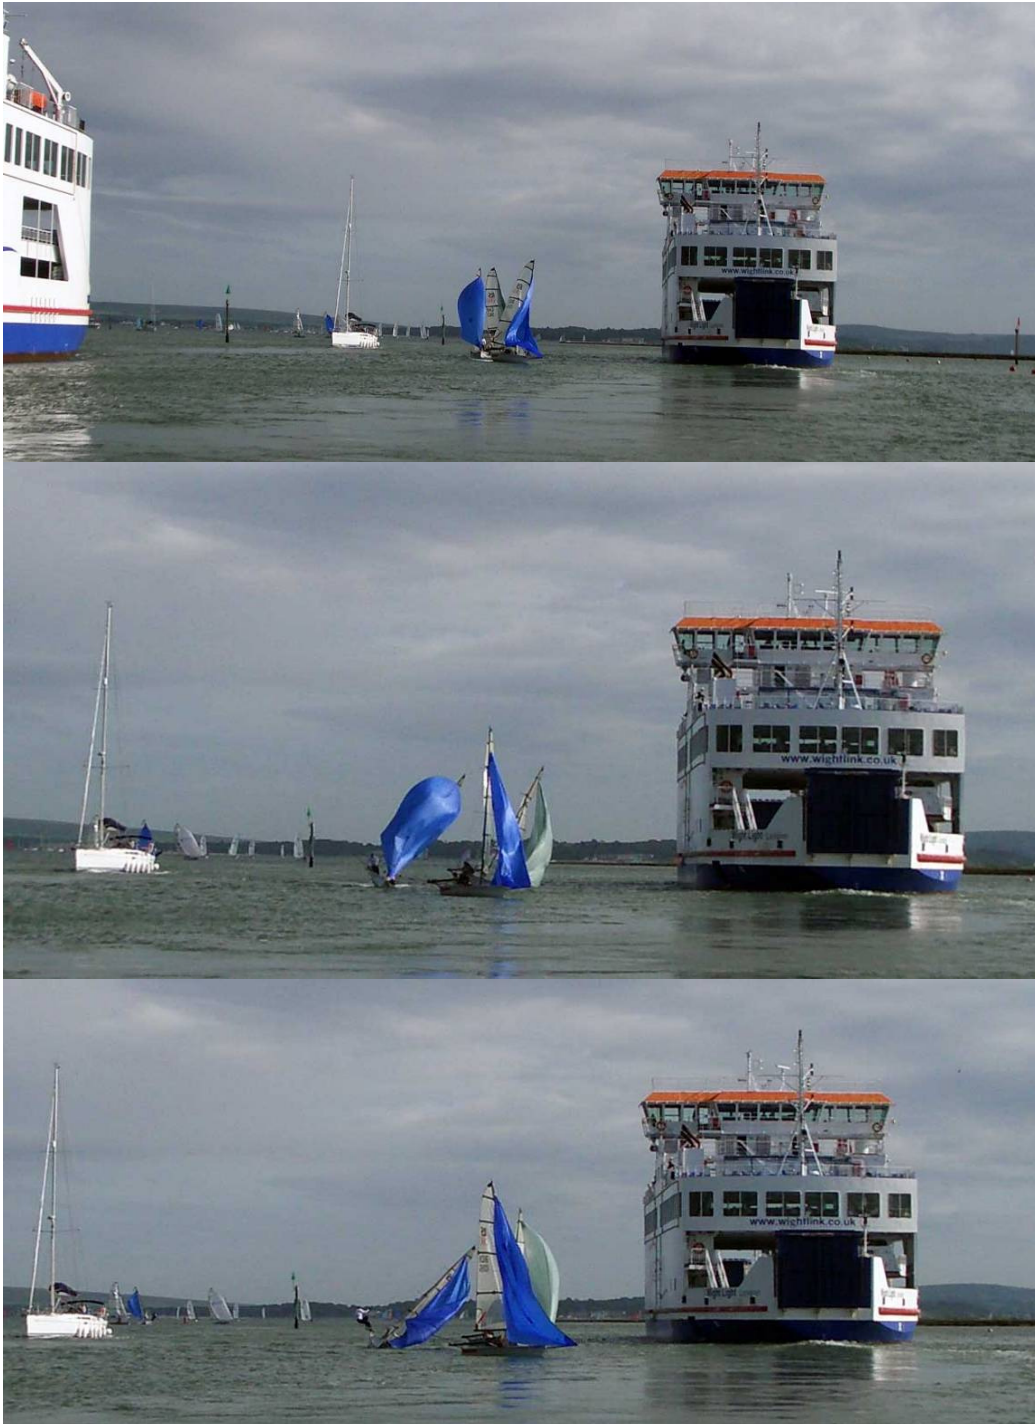
Figure 10: Effect of Ferry Wind Shadow on three RS dinghies

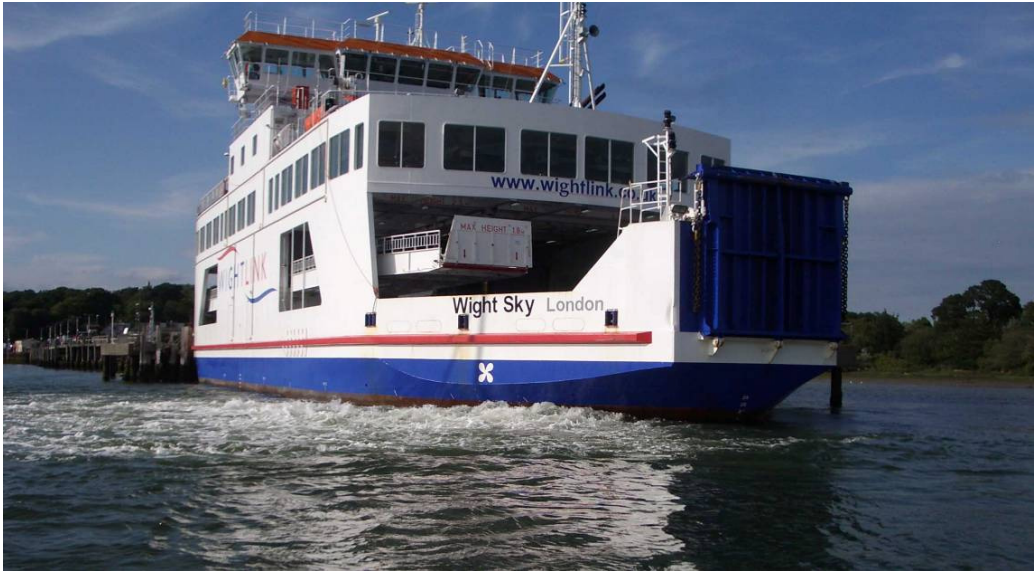
Figure 12: Aft Thruster Slipstream while Berthing

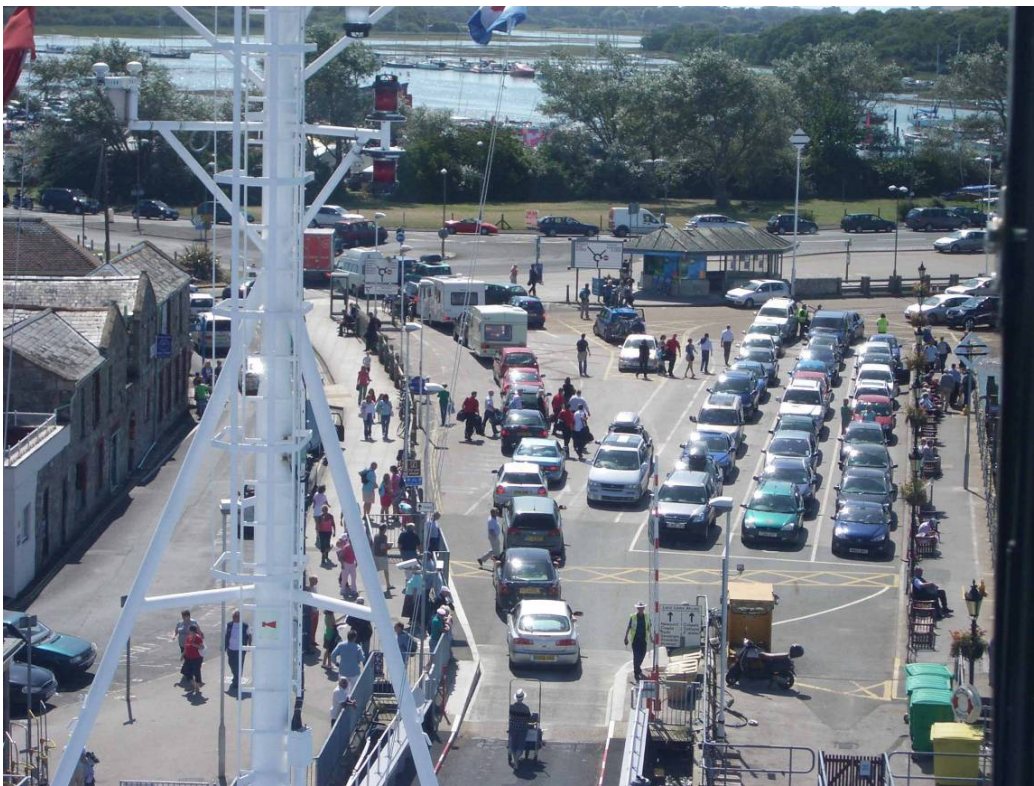
Figure 4: Congestion at Yarmouth Quay

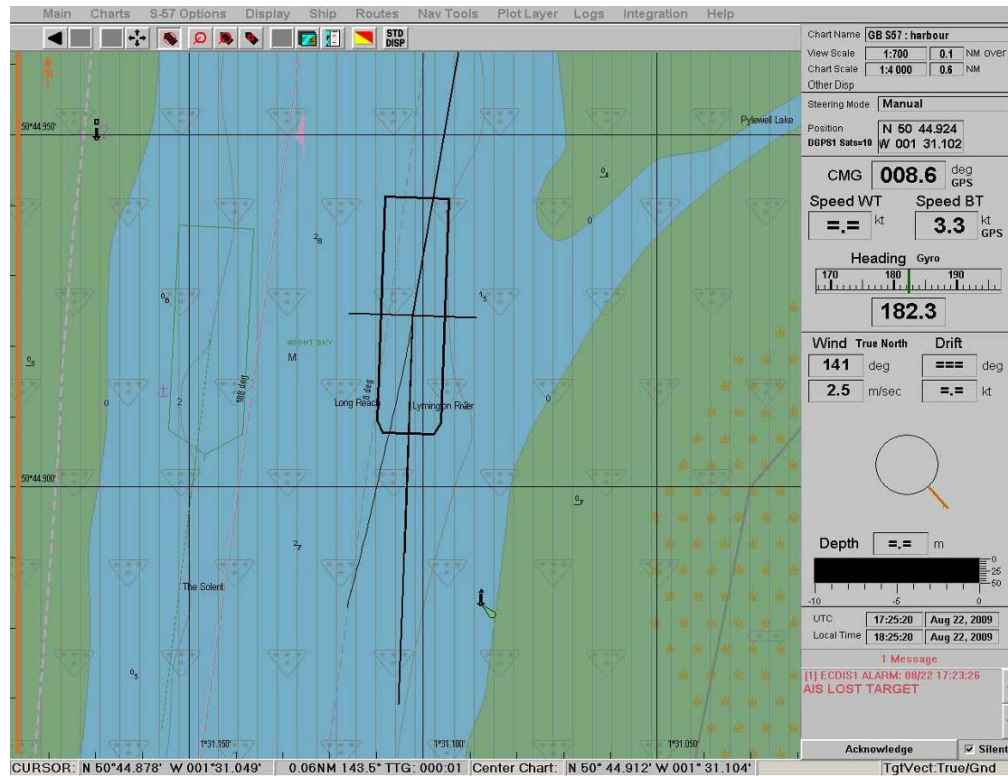
Figure 6: ECDIS Plot Showing Passing at 18:25:30. Ships not on Leads

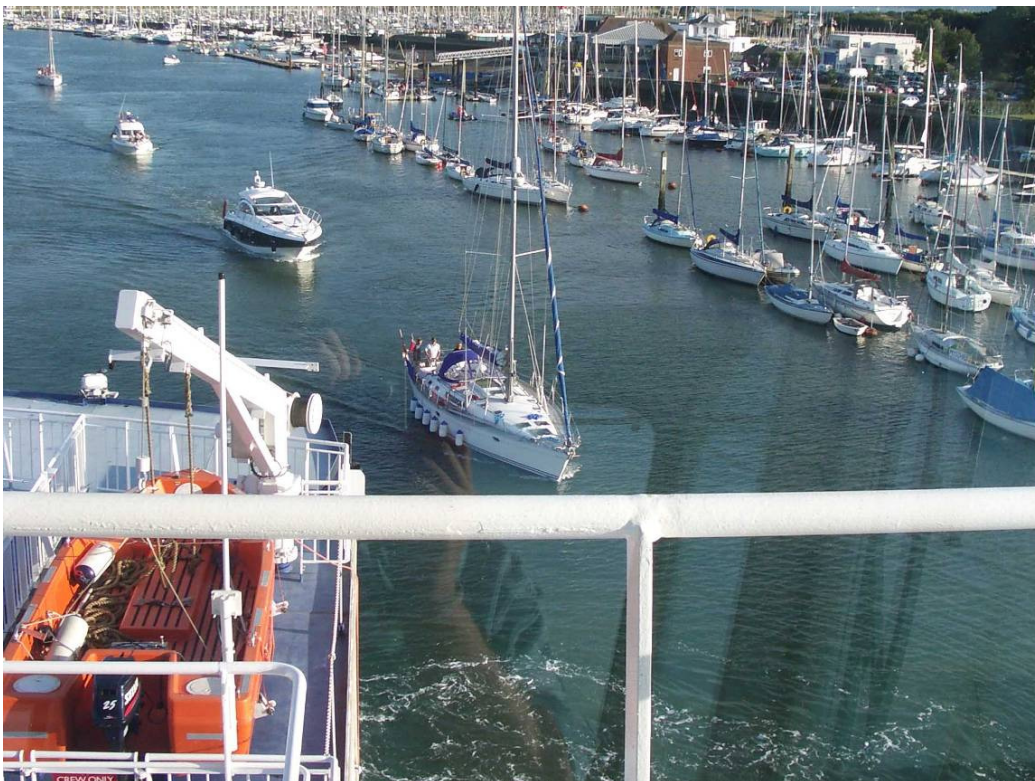
Figure 11: Leisure Craft passing the Ferry Stern while it is Berthing

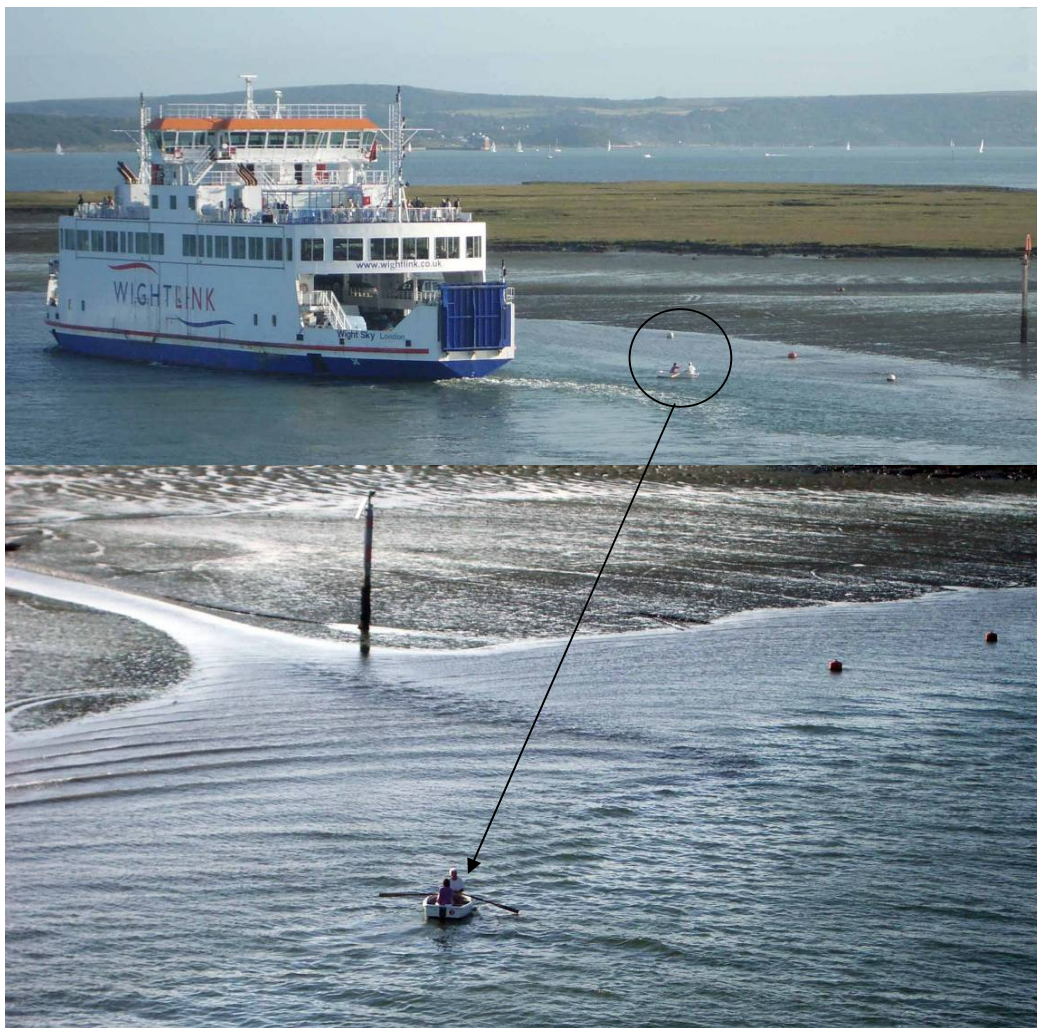
Figure 12: Small Boat Occupants without Lifejackets.
