Safety of Wightlink Propulsion Units on Lymington – Yarmouth Ferries

Summary

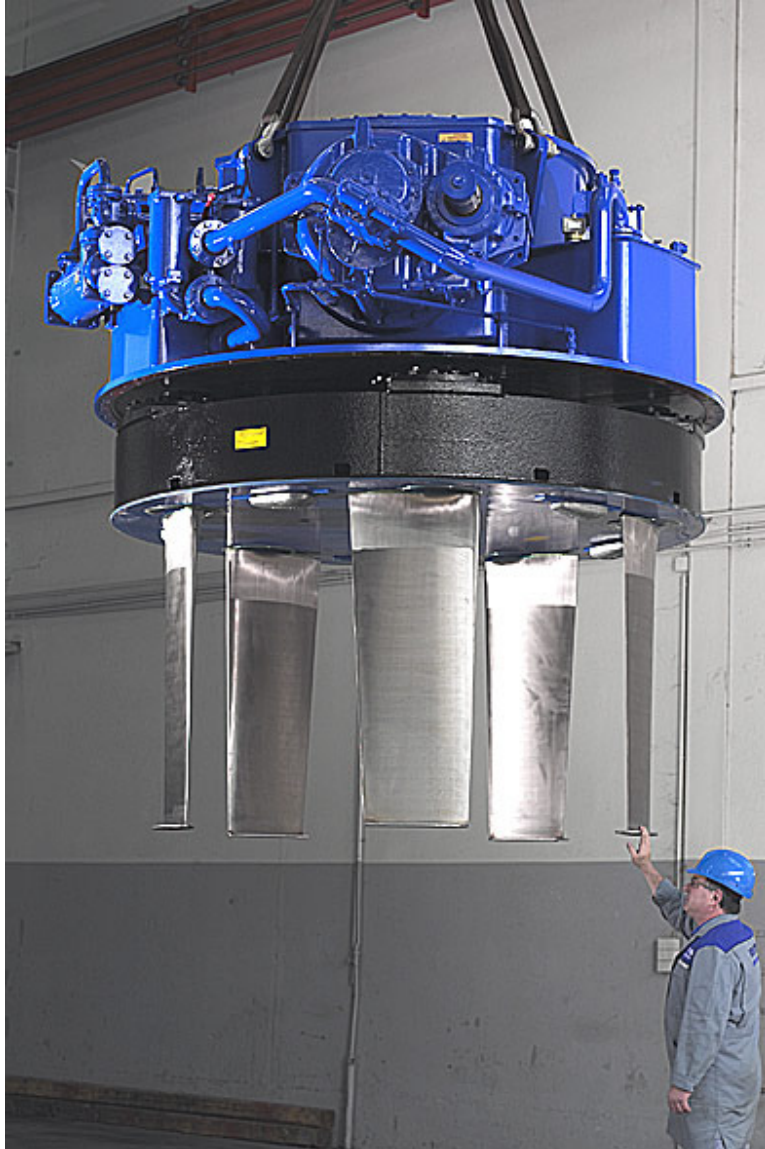
Figure 1 - A Voith Schneider propulsion unit of similar size to that fitted on W-Class ferries

- 2 The propulsion arrangements on both the C and W-Class vessels which allow them to navigate in the shallow Lymington River have the potential to make a significant hazard contribution. These “thrusters” are Voith-Schneider propulsion units – there is no conventional propeller or rudder. There are two very large units and Figure 1 shows a unit which is of very similar size to that on the W-Class ferry, the blades are 1.35m long and 2.1m in diameter. The thrusters push a large flow of water from one side of the unit to the other – the propulsion flow, really a big and high velocity jet of water. The existing ferries have similar but significantly smaller units (see Figure 2). Wightlink have found it necessary to increase the power output of their engines from 800hp to over 2360hp, nearly

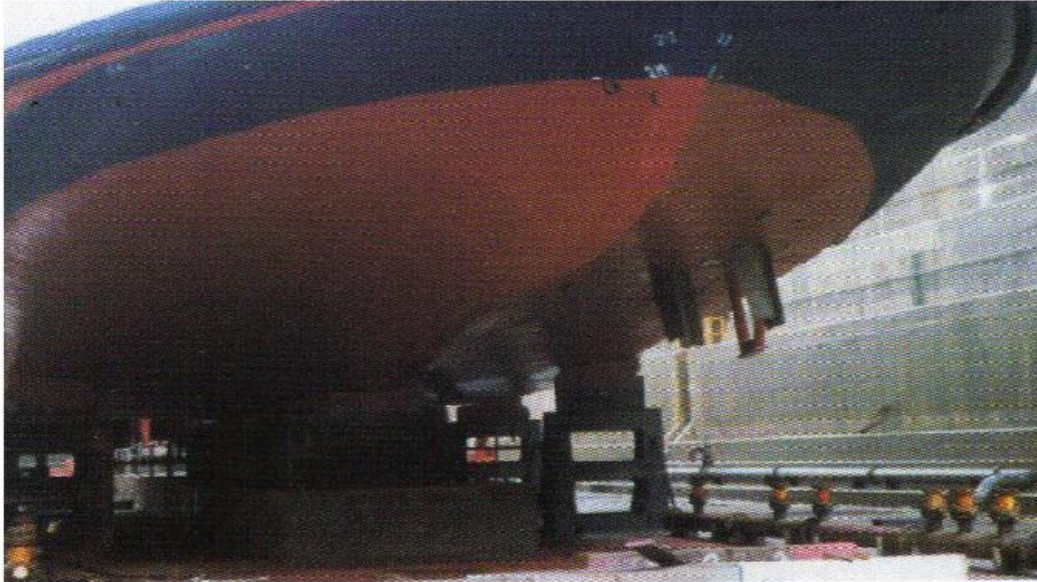
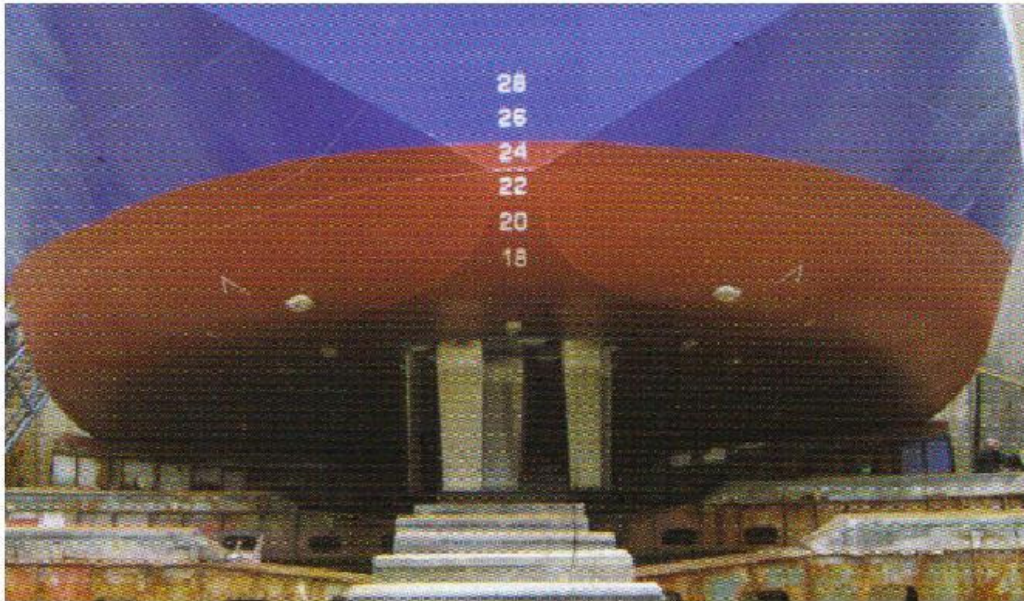
Figure 2 – Comparison of thrusters on C and W – Class ferries

**Current C Class Ferry
Small thruster on one side**

**New W Class Ferry
Large thrusters on centre line**

- 5.9 On the C-Class ferries (in Force 9 crosswind), each thruster will be moving about 7.4te/s of water at a mean speed of about 5.2m/s across the channel and its banks; on the W-Class, the figures for each thruster are 15.6te/s at 5.8m/s. For the W-Class ferries in strong wind conditions, the flow of the water column across the river channel, re-circulated by the thrusters, will take as little as 30-60 seconds.

- 5.11 LRA's list of river incidents shows that about 1/3 of the incidents were either caused by or significantly contributed to by the effects of thrusters. The effects are known to be radically different from the C-Class, which showed a clear wake from both thrusters and it was obvious to other users where to keep clear.
