Lymington Ferries Summer Review 2009

Reference: 31098//D0356/Issue 1.1

Date: 19 November 2009

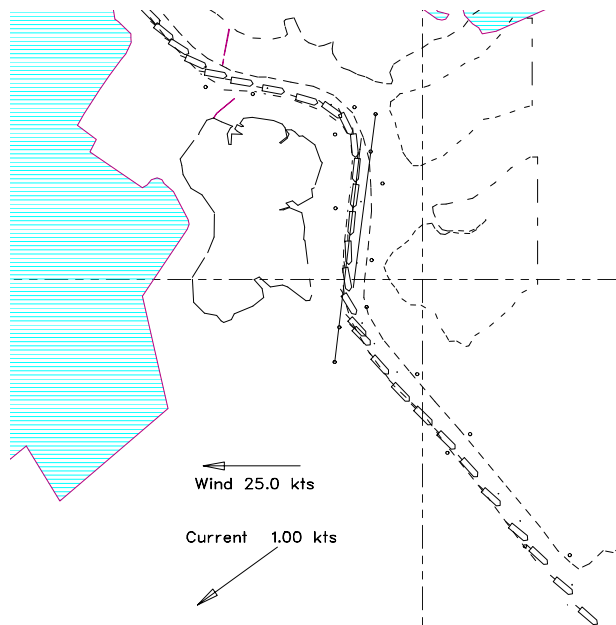
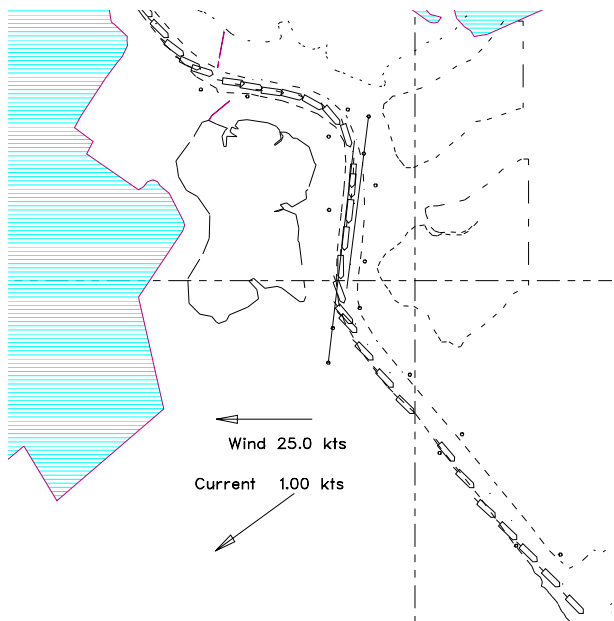
stayed close to the inside of the bends if traffic conditions permitted; such a track helped the exit from the bends and improved the set-up for the next. This generalisation depends, of course, on the weather and tidal conditions prevailing at the time and Figures 4 and 6 show that the track was to the outside of the channel at Tar Barrel in the easterly wind and ebb flow met on the day;

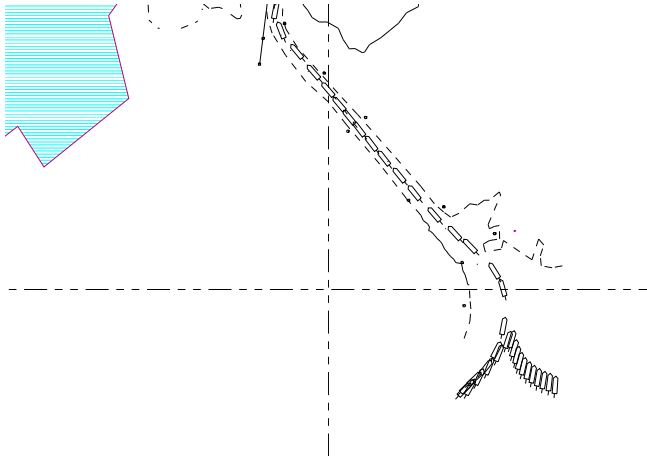
Low speeds were recorded at times in all the inbound runs. Run 104 began with a lengthy wait of some 5.5 minutes outside the river until the outbound ship sailed. During this wait speeds were around 1.4 knots overground, arising in part from the combined effects of the wind and the local current in the Solent at the time (Figure 14).

Figure 14: Wight Light Waiting at River Mouth on 22 August 2009. Run 104

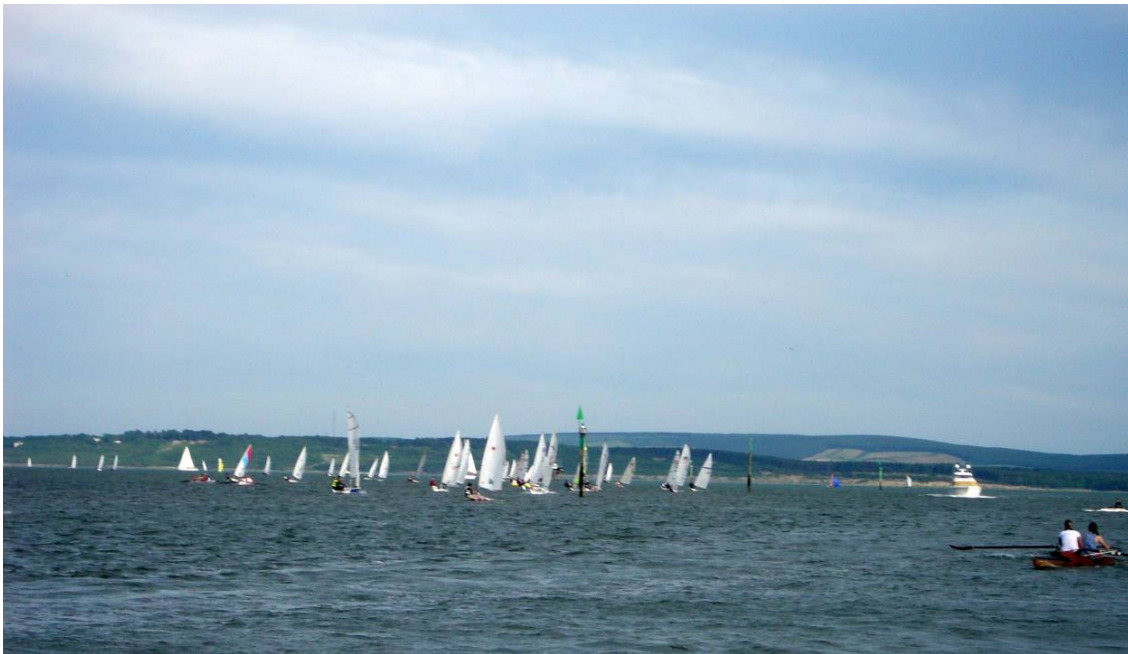
It was noted that, when a sailing regatta or evening racing was on, the fleet moved down the river to the Solent in packets of locally high density traffic. On most occasions these packets managed to move down-river between ferry sailings so that they were clear by the time a ferry made its river passage. Figure 16 shows a packet of high-density traffic moving ahead of a ferry in Long Reach.

Figure 16: Packet of High-density Traffic moving down Long Reach at 18:47 on 24 June

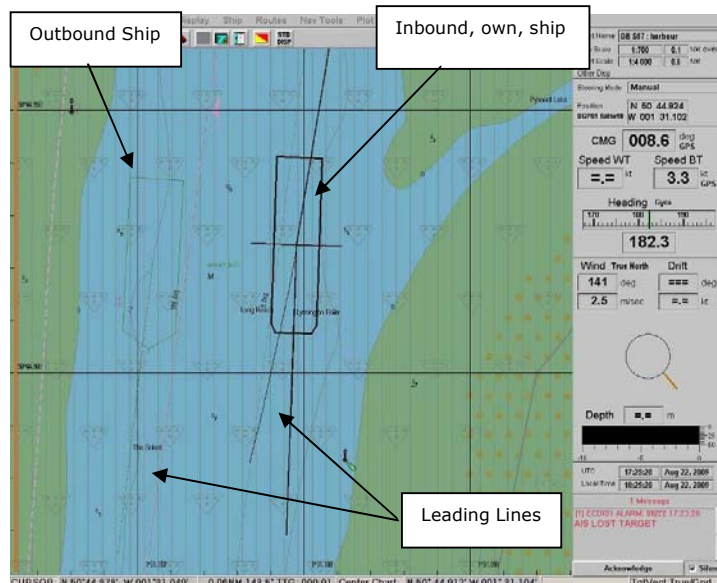
Figure 21: Use of Leading Lines on LWS Pass; both Ferries Outside Leads.

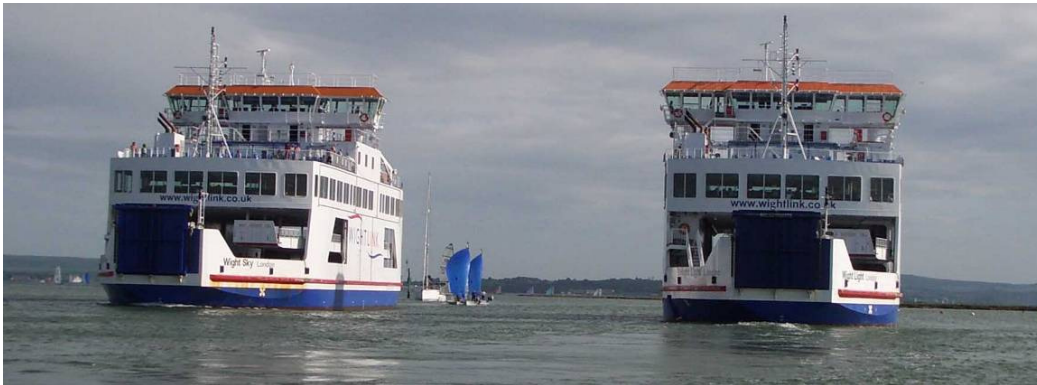
Figure 22: Wight Light (on the right) and Wight Sky passing

At this time (1743 BST) the mean wind was about 10 to 15 knots from a south-westerly direction and two RS dinghies can be seen off the Wight Sky's port quarter, flying spinnakers and reaching. The crews in two of these dinghies were seen to be standing in the boat or on the weather outriggers. What happened next vividly demonstrated the effect of the ferry wind shadow on high-performance sailing dinghies.

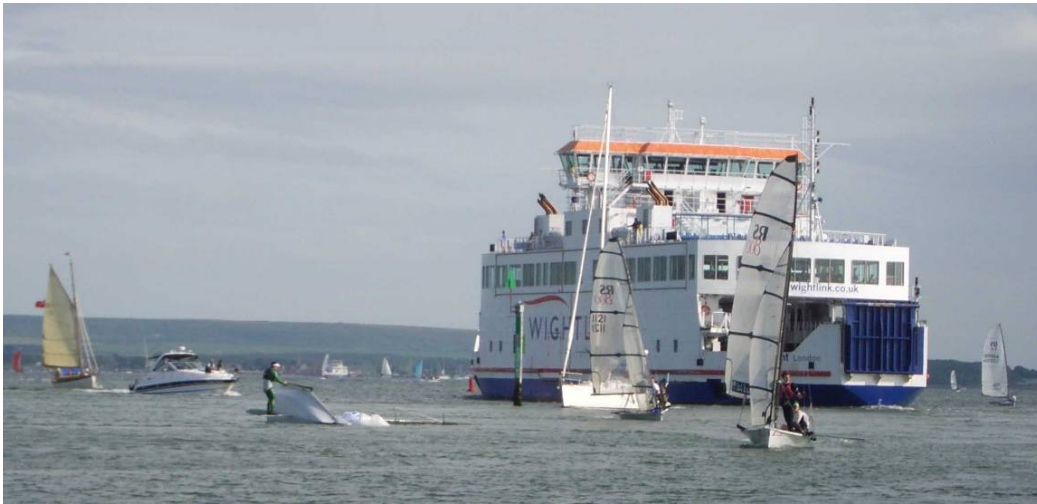
The same could not be said for the next group of RS dinghies, seen in the background of the photos in Figure 23 and moving up-river on a reach without spinnakers set. Having seen their fellow sailors caught in the ferry wind shadow, they were caught in the same way as they passed the outbound Wight Light, the ferry by this time having rounded the Tar Barrel mark. The same progressive loss of wind occurred and one of the dinghies in the group did in fact capsize as shown in Figure 24.

Figure 24: Capsized RS dinghy

It was soon righted by the crew who resumed sailing with, apparently, no ill effects.

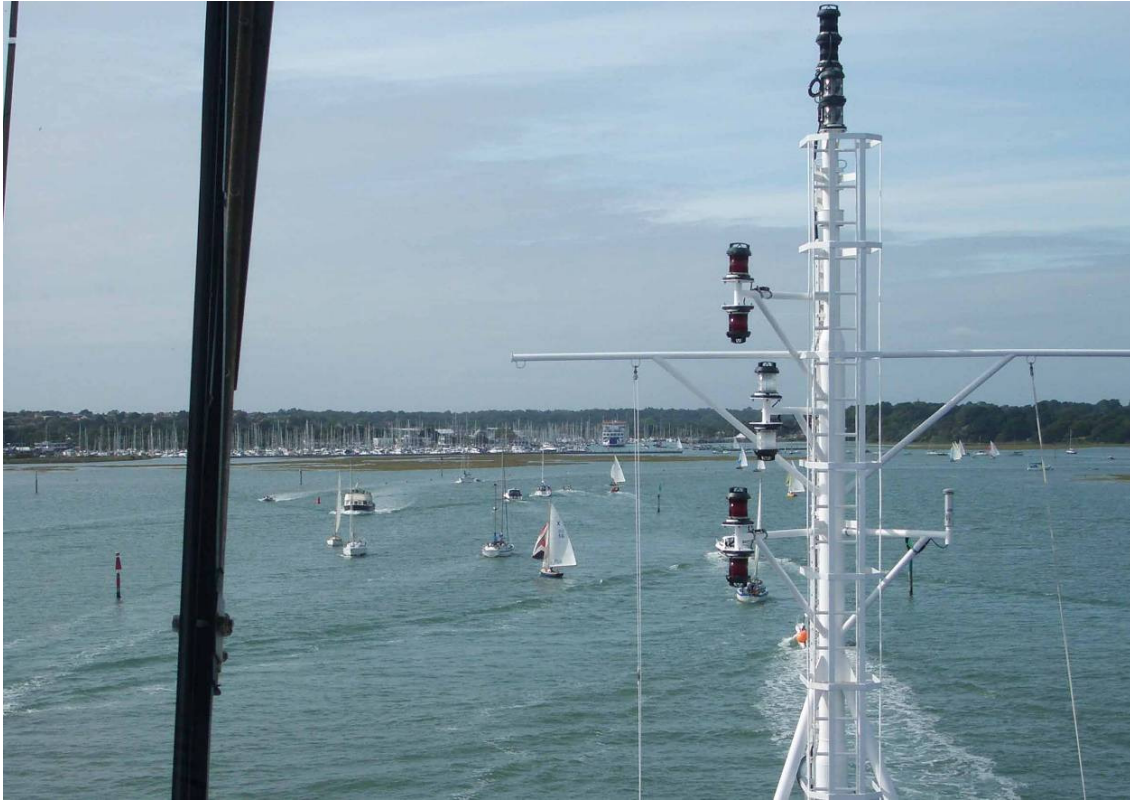
In general it was apparent that users complied with the lane discipline requirements in the ColRegs. This was helped by the Harbour Master's patrols which encouraged users both to keep to the right side of the channel and maintain a proper speed. The presence of a ferry approaching from ahead or astern was also a powerful motivating factor in causing users to keep to the right side of the river as Figures 26 and 27 demonstrate.

Figure 27: Improved Lane Discipline in Long Reach at 16:00 on 22 August as Ferry Approaches

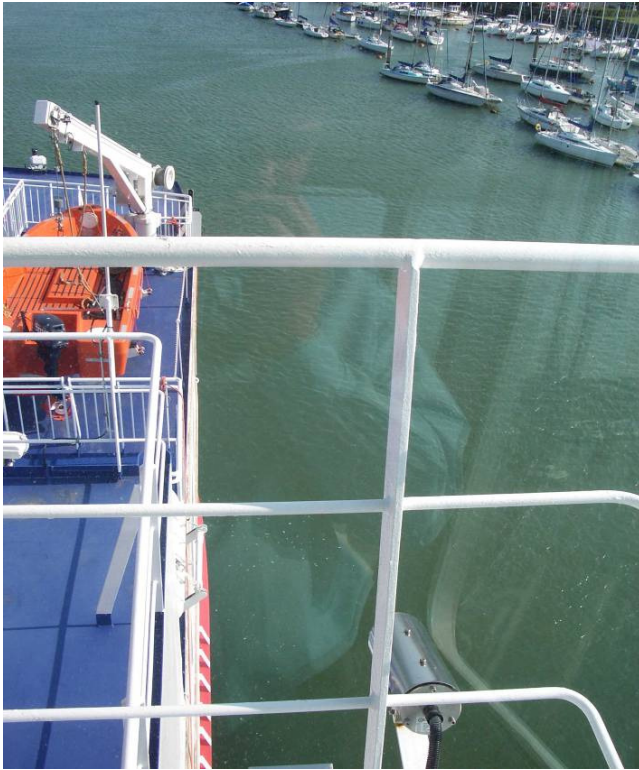
- This, and a similar use of the thrusters while berthed at Yarmouth mentioned above, appears to contravene the early, and often repeated, assurance that the W-class thrusters would be stopped while the vessel was berthed. Indeed, if use of the thrusters is necessary to hold the ship in a strong easterly wind at both Yarmouth and Lymington, it suggests that mooring arrangements at both terminals are not satisfactory for winds which set the ship off the berthing face;

Figure 5: On Berth at Lymington. Aft thruster on 10%. About 1648 BST on 11 May 2009

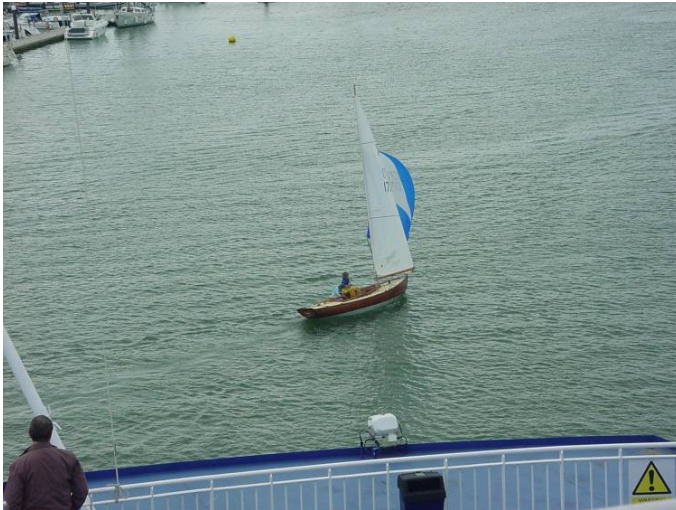
Figure 1: X Boat crossing dangerously ahead at wave screen

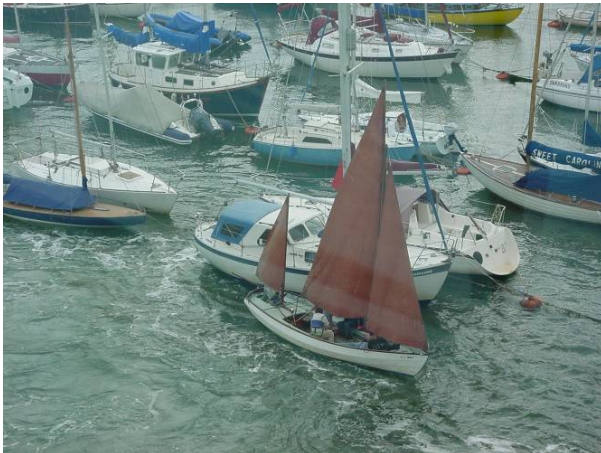
- 3) Wight Sky (Roy Nichols). RN also felt that the decision when to operate in strong winds should now be left to the Master. Most of the time on the river was without incident. Wind shadow effect was noticed with several yachts, but without any difficulties being noticed. However, on the "busy" run in between 1615 (Starting Box) and 1625 (Wave Screen) the ferry coped with the influx of X Boats. Emergency action was required at the wave screen when two X Boats crossed very close ahead of the Wight Sky, necessitating an emergency stern thrust movements accompanied by sound signals. The sail numbers were noted X170 and X178. The ferry coped well. While Wight Sky was berthing a small yawl, under sail only, tried to pass the ferry berth and was affected by the thrusters.

Figure 2: Yawl under sail only (light airs) experiencing difficulties when trying to pass Wight Sky during berthing

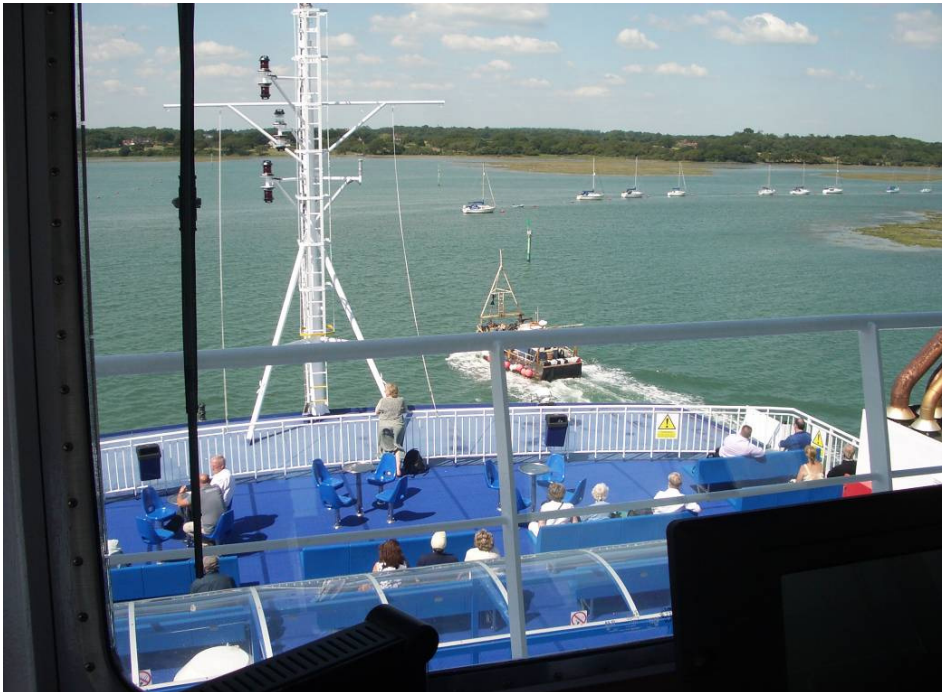
Figure 1: Fishing Vessel passing ahead of Ferry

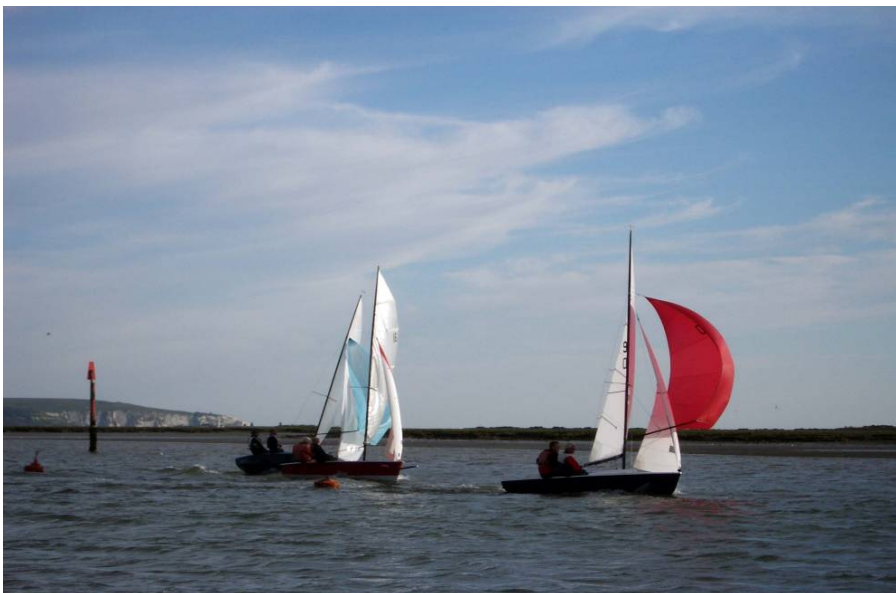
Low water occurred while the dinghies were racing in the Solent, the leading boat approaching the Cocked Hat Bend area about an hour after the tide was at its lowest for the evening. Even so, the height of tide was still low at around 0.8 to 0.9 metres. This was sufficient, however, to allow the returning dinghies to pass outside and to the west of the channel on the approach to Cocked Hat (Figure 6), helped by the fact that they were on a close reach with, perhaps, the centreboard wholly or partially raised.

Figure 6: Dinghies Sailing outside Channel with Tide Height about 0.8m

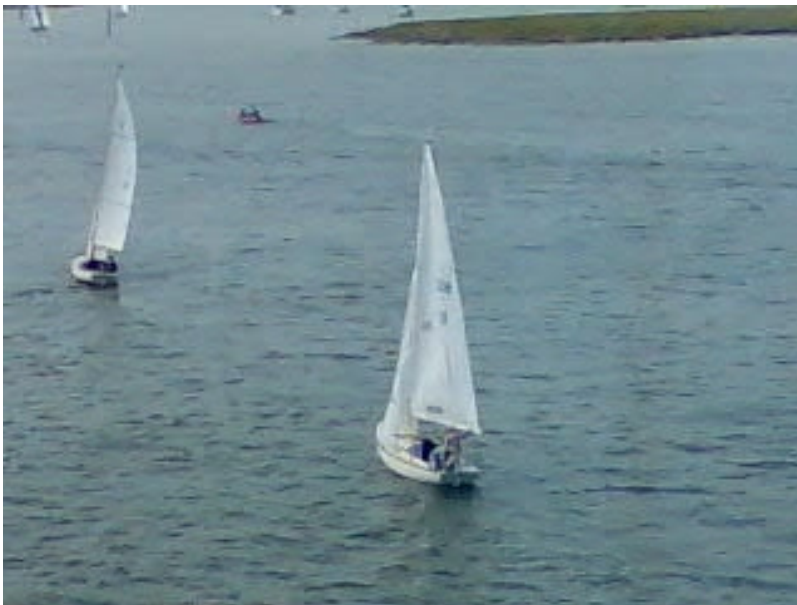
Figure 2: F boats returning to Lymington passing the WIGHT SKY. Wind shadow clearly visible.

Some four Folkboats navigating down the East of the channel between 1640 and 1643 did experience some wind shadow effect from about two points abaft the ferry beam to about 6 points abaft the beam (see picture) in the light winds prevailing. The remainder of the crossing went without incident.

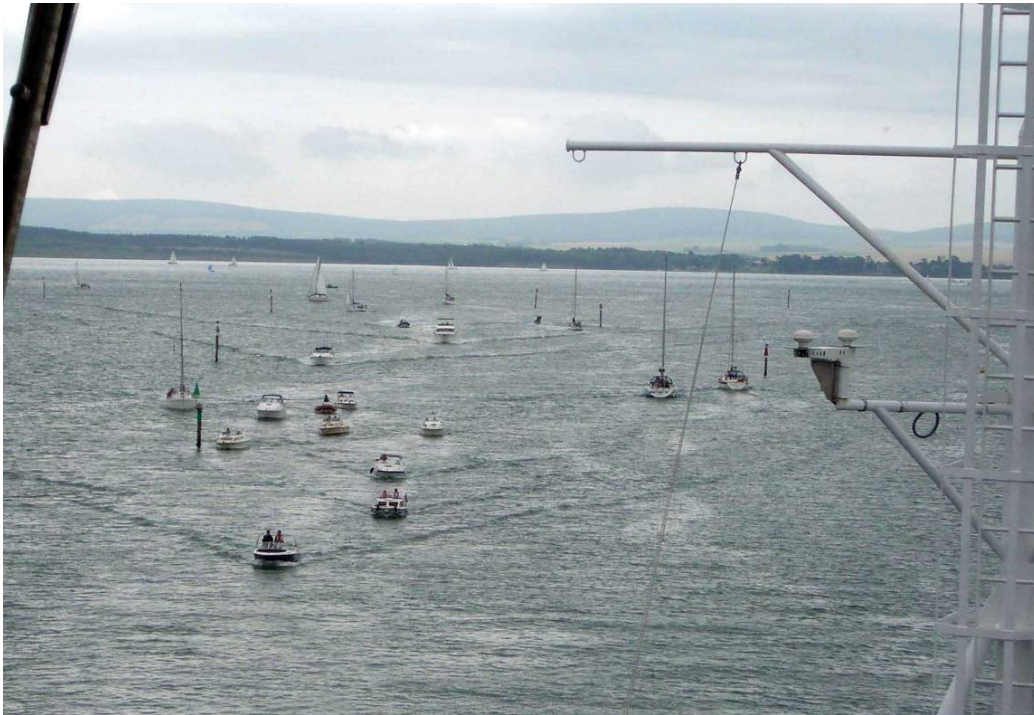
Figure 3: Traffic discipline in Long Reach

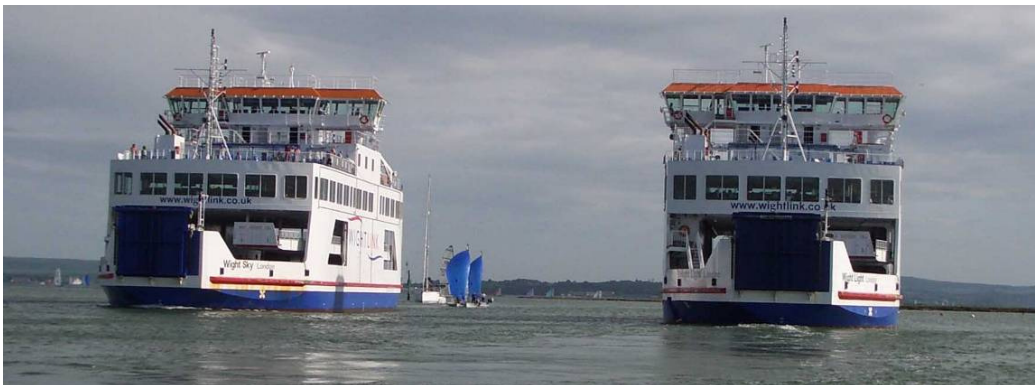
Figure 9: Wight Light (on the right) and Wight Sky passing

At this time (1743 BST) the mean wind was about 10 to 15 knots from a south-westerly direction (Figure 1 - Wind Measurements) and, as can be seen in Figure 9, two RS dinghies off the Wight Sky's port quarter were flying spinnakers and reaching. The crews in two of these dinghies were seen to be standing in the boat or on the weather outriggers. What happened next has been described by Captain Noble in Reference 1 and vividly demonstrated the effect of the ferry wind shadow on high-performance sailing dinghies.

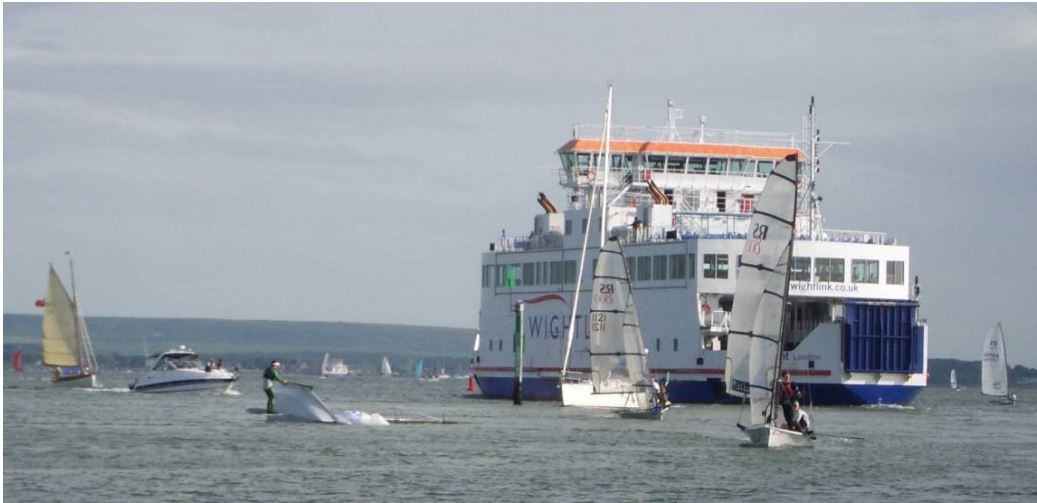
seen their fellow sailors caught in the ferry wind shadow, they were caught in the same way as they passed the outbound Wight Light, the ferry by this time having rounded the Tar Barrel mark. The same progressive loss of wind occurred and one of the dinghies in the group did in fact capsize as shown in Figure 11.

Figure 11: Capsized RS dinghy

It was soon righted by the crew who resumed sailing with, apparently, no ill effects.

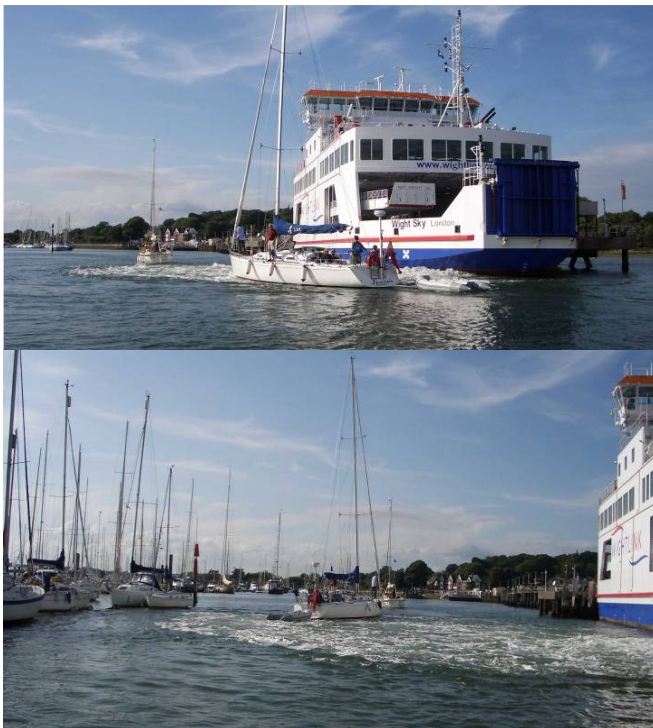
Some leisure craft were passing the ferry at the time and the effect on a yacht, motoring past, is shown in Figure 13.

Figure 13: Effect of Thruster Slipstream on Passing Leisure Craft

It is clear that the effect of the slipstream on the passing keelboat was quite severe, although it is not known to what extent avoiding action was taken on board the yacht. Its keel would have been affected by the vorticity in the thruster slipstream beneath the water surface and the resultant excursion, while not enough to take the yacht into the nearby moored vessels, was large.

- It appears that the "half"/"half" setting is activated at variable locations along Horn Reach, presumably due to the weather conditions at the time, rather than on the whim of the bridge team. If done early, and excessive percentage power used, it can cause problems for nearby leisure craft. It is suggested that a location for the earliest activation of the "half"/"half" setting is agreed with Wightlink to avoid undue disturbance to leisure users in Horn Reach;

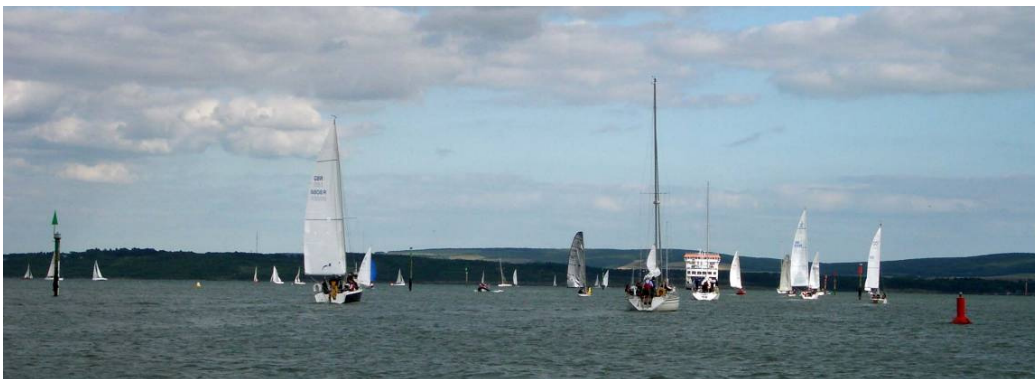
Figure 3: Traffic in Long Reach: Ferry at Seaward End

It is seen that not all the outbound vessels were keeping to the starboard side of the channel. However, as the ferry continued along the Reach, keeping to starboard and leaving room for small craft outside her, the outbound traffic all moved to the correct side of the channel as shown in Figure 4.

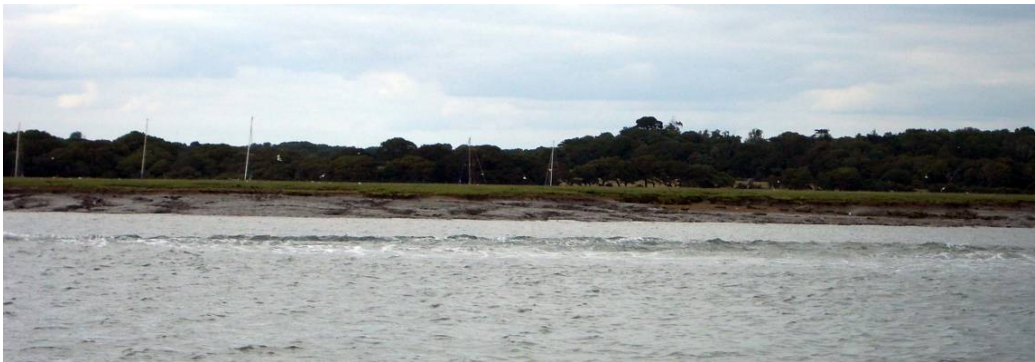
However, a small number of those sailing in the evening mentioned how shallow they believed the river to be in various places, and were of the opinion that this reduction in depth had occurred recently. One area mentioned was in the known shallow patch in the general vicinity of Number 7 post where the inbound ferry tripped the breaking wave shown in Figure 5 for a brief period. Another area was in the Solent where one of the larger keelboats was felt to have touched bottom; other leisure users asserted that the ferries had recently grounded "at least three times in the river". No dates, times or locations were given to support this assertion, however.

Figure 5: Breaking Wave in Shallow Region outside Channel in Long Reach

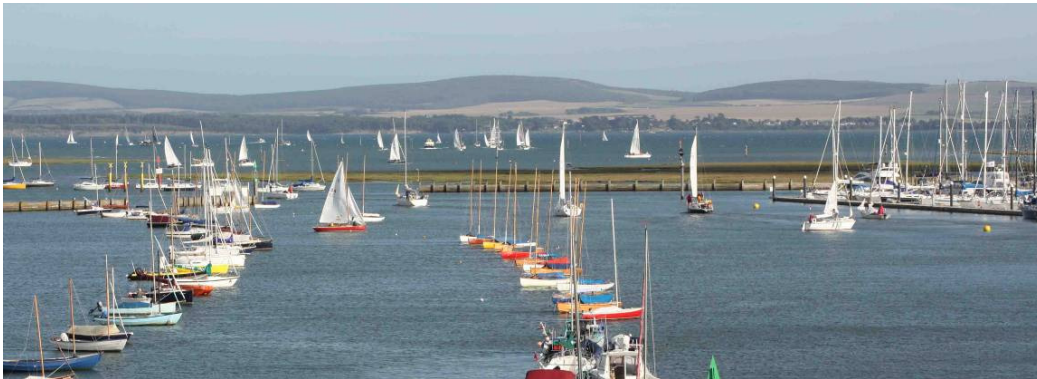
Figure 3: Sailing Fleet moving down River as Wight Sky Departs Lymington

- By this time most of the sailing fleet was well down the river (Figure 3).

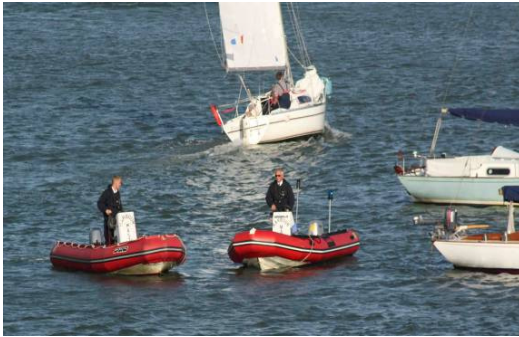
Figure 4: Harbour Master patrols at Start of Observation Period

- Both Harbour Master's RIBs were on patrol as shown in Figure 4. They are shown in the vicinity of the Harper's South post and were not observed further down river. One RIB was still on duty at the end of sailing when all yachts had returned; it is shown in Horn Reach at the end of proceedings in Figure 5.

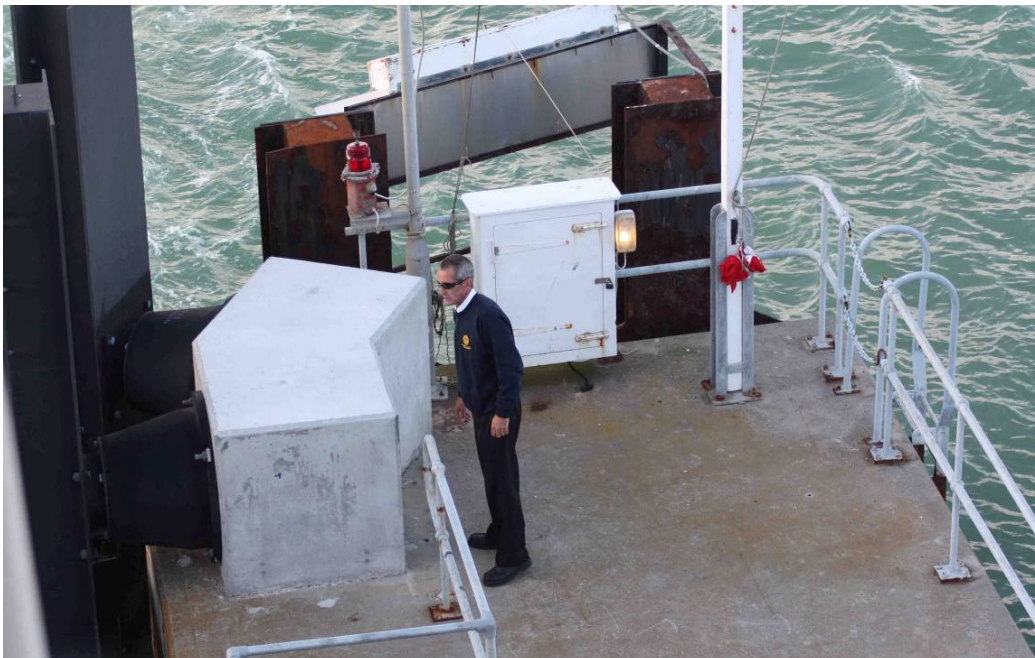
Figure 6: Shore Staff Checking Bow door at Yarmouth

- On leaving Yarmouth, the bow door check was done by a member of Wightlink shore staff as shown in Figure 6.

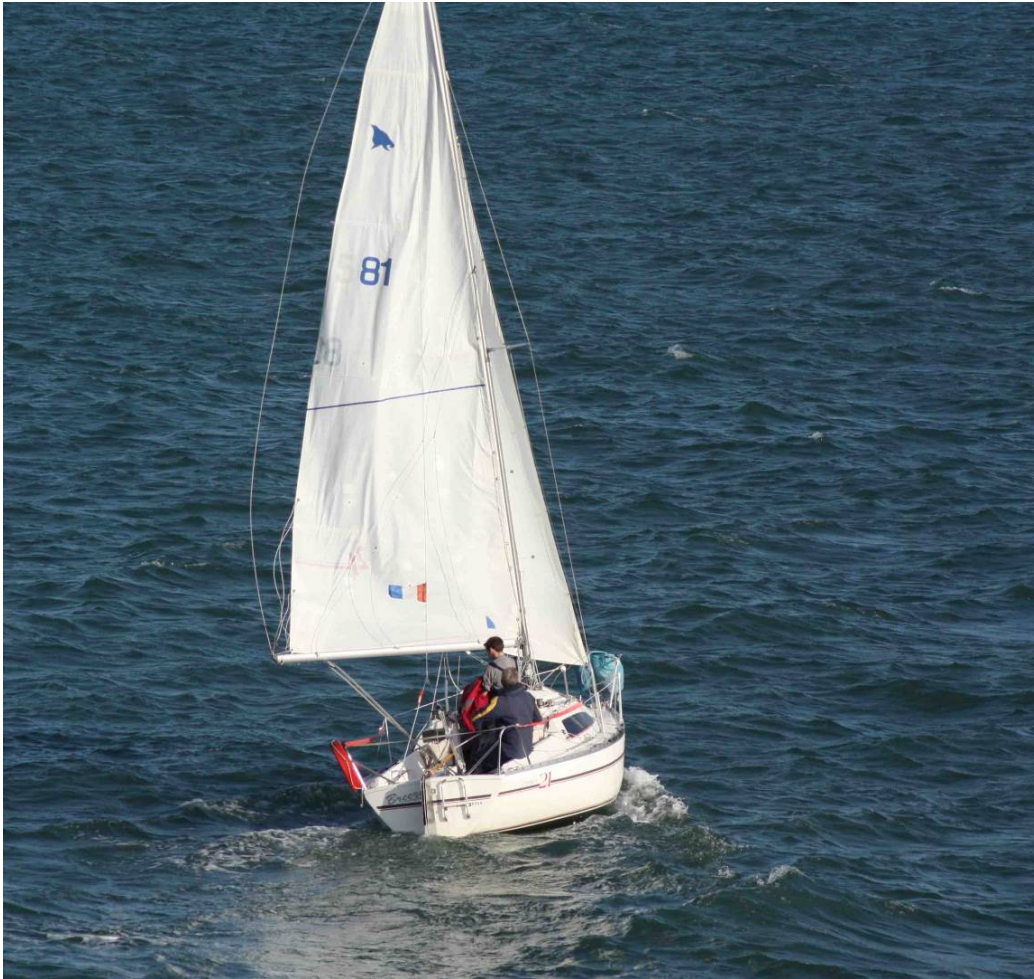
Figure 10: Yacht Ahead of outbound Wight Sky in Long Reach

- In general the behaviour of the leisure users on the river was excellent. Only one vessel, which appeared to be a visitor, showed poor discipline by wandering across the bow of the outbound Wight Sky at the seaward end of Long Reach. It appeared that the ferry had not been noticed by those on board, because, once it had, the boat ceased dawdling and moved smartly out of the way (Figure 10).

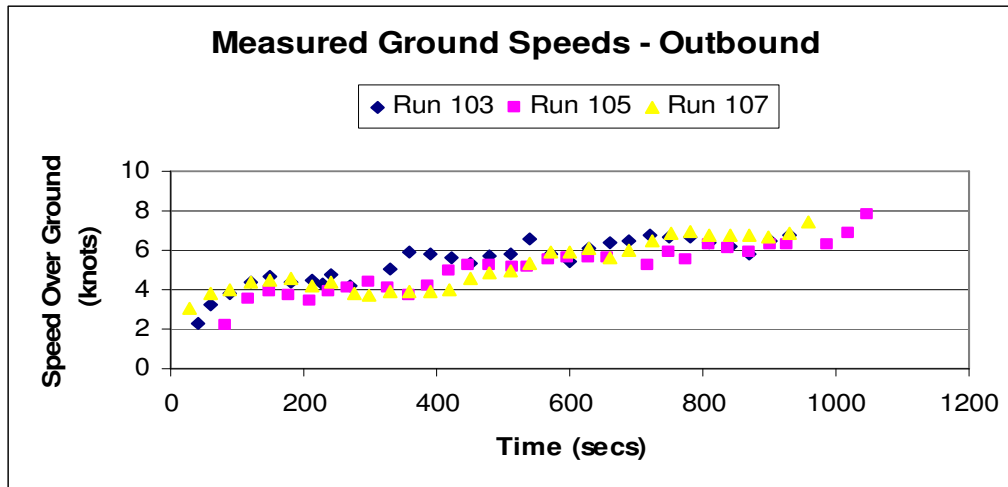
Figure 2: Measured Overground Speeds, outbound

It is seen that when outbound, speeds in Long Reach for two of the runs rose to values a little above the 6 knot limit, before increasing at the end of the Reach at the start of the Solent crossing. It should be noted however, that run 107 took place with the early ebb running so it was likely to have experienced a following current. The 4 knot advisory limit in Horn Reach was well observed.

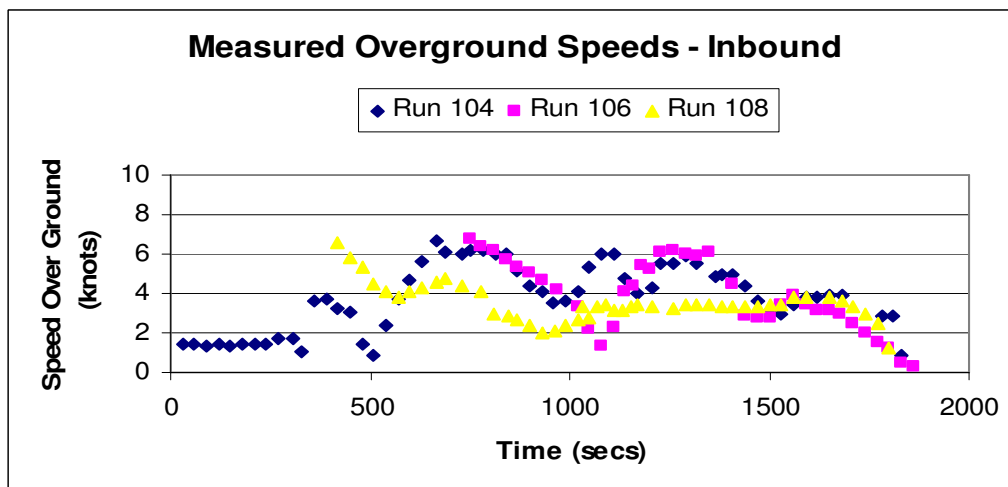
Figure 3: Measured Overground Speeds, inbound

Inbound run 104 was characterised by a period of some 5.5 minutes at low speed while the Wight Light had to wait at the mouth of the river for the outbound ship to leave the Lymington berth. Overground speeds in run 108 were generally low due to the fact that this passage was carried out in very low water conditions and these, together with the fact that a passing manoeuvre was carried out in the Short Reach lay-by, demanded that the ship was navigated with care and at a prudent, low, speed. The low speed on inbound run 106 just after the 1000 second timing was occasioned by the need to adjust timings to pass the outbound vessel in the lay-by. It is seen that, while in this run the 4 knot speed limit was adhered to inbound, the 6 knot limit was slightly exceeded in Long Reach.

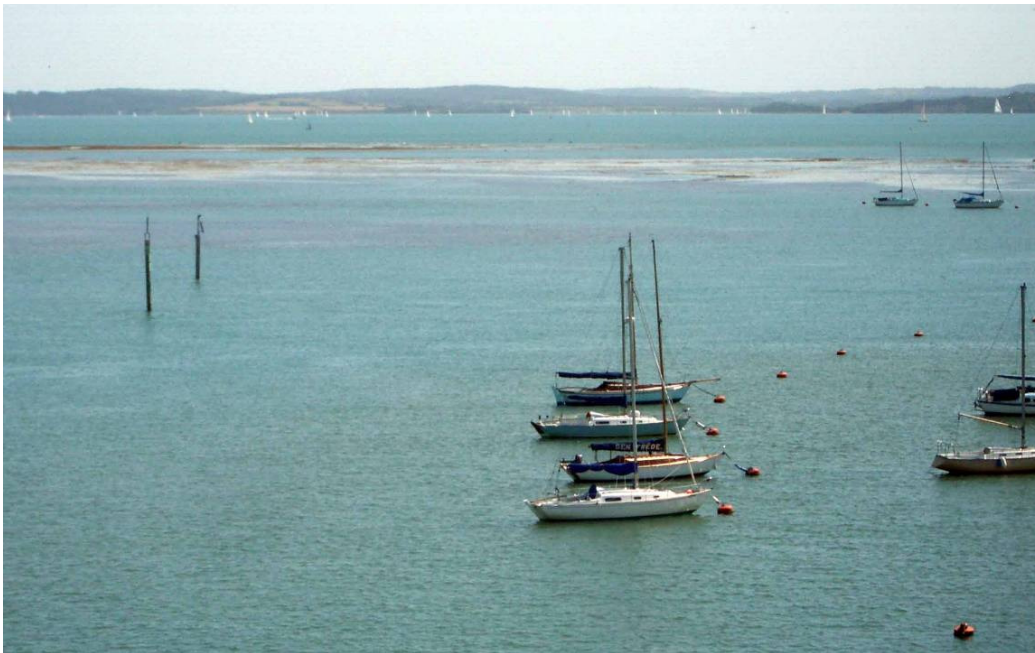
Figure 5: Yachts Moored near Cocked Hat

Figure 5 shows how moored yachts near Cocked Hat intruded into the navigable channel. This was noted in the first outbound run close high water when the wind was about 6 knots from the south-west, setting the wind-rod vessel into the channel. It may be

noted that the mooring of boats in this region was not encouraged in the BMT Phase 2 report.

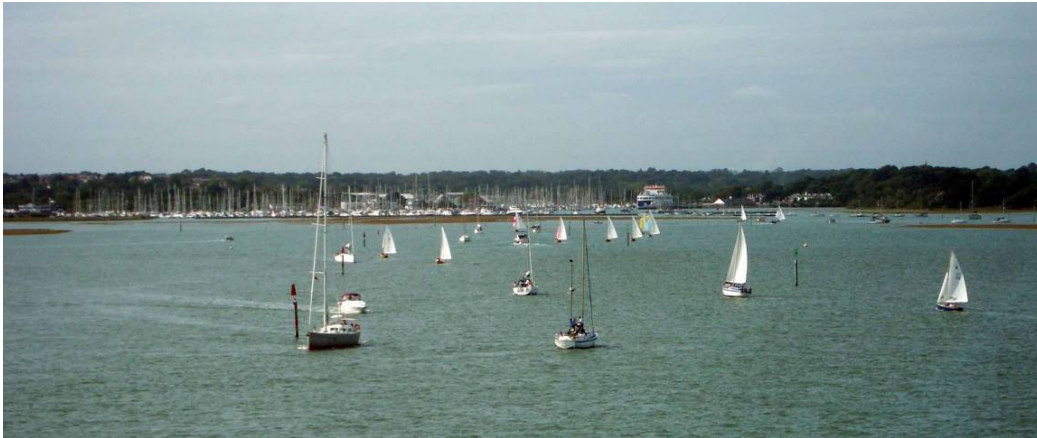
Figure 7: Colreg indiscipline in Long Reach (from ferry)

Most leisure users seemed to be able to live with this, albeit with some indiscipline when there were no ferries ahead (see Figure 7)....

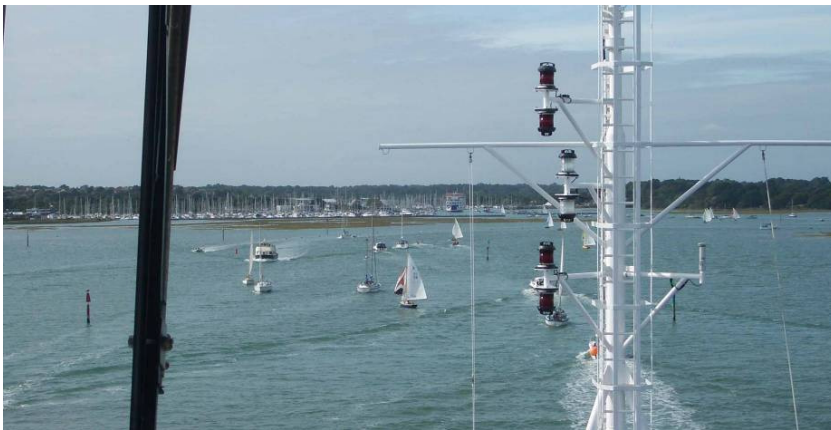
Figure 8: Colreg discipline in Long Reach

....but this was much improved when it was clear that a ferry was around. (See Figure 8)

Although there was some indiscipline, in general the ColRegs were well observed by the majority of leisure users on the river that day.

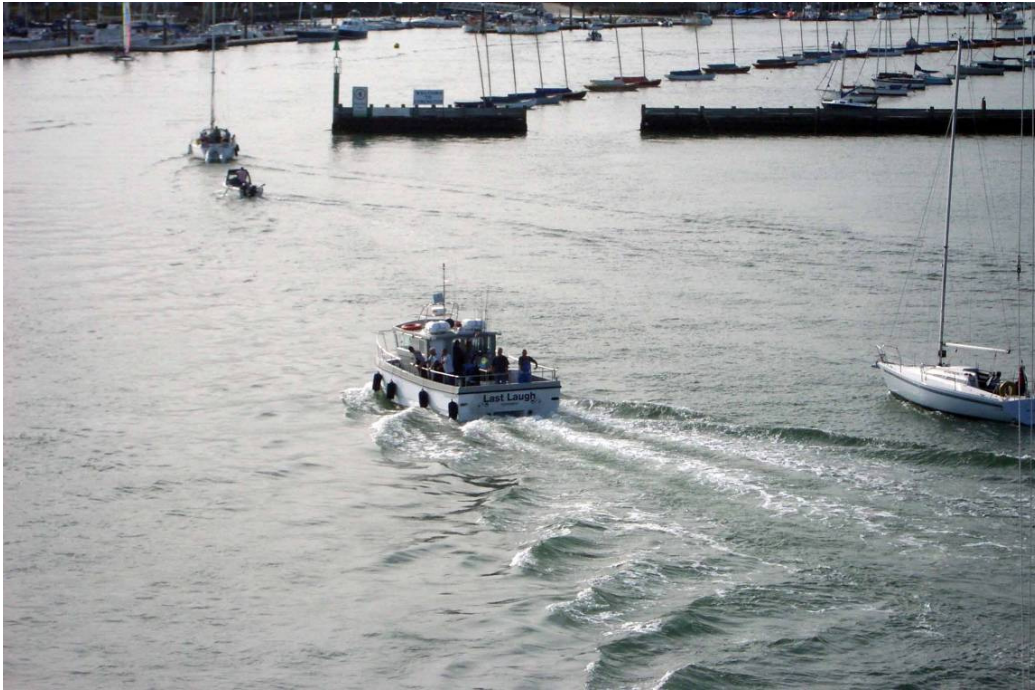
Figure 9: Small Boat Wash

Wash from the ferries was minimal, but some small craft were observed giving rise to what seemed to be excessive wash (Figure 9)

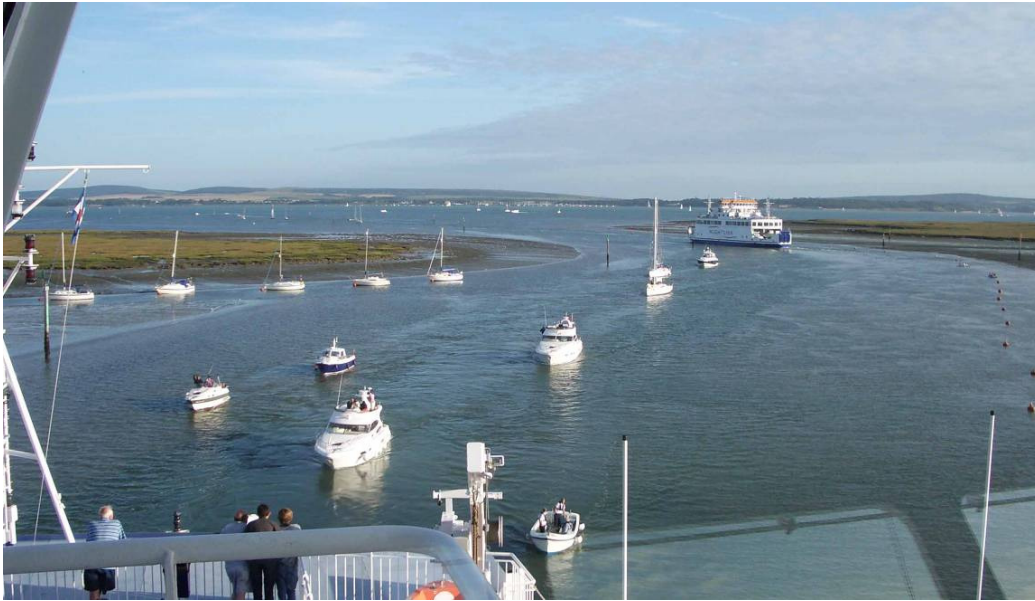
Figure 10: Queue astern of Ferry during Low Water Passage

The Wight Light was inbound near to low water in the evening and, as has been noted above, adopted the prudent course of using a low transit speed in the river. A consequence of this is that inbound leisure users found themselves in a queue astern of the ferry as it moved up river (Figure 10).
